SPOKANE INTERNATIONAL AIRPORT PASSENGER BOARDING BRIDGE CONDITION ASSESSMENT

SPOKANE INTERNATIONAL AIRPORT

AERO SYSTEMS ENGINEERING, INC.

ASE PROJECT NO.:
118716GEGGEG

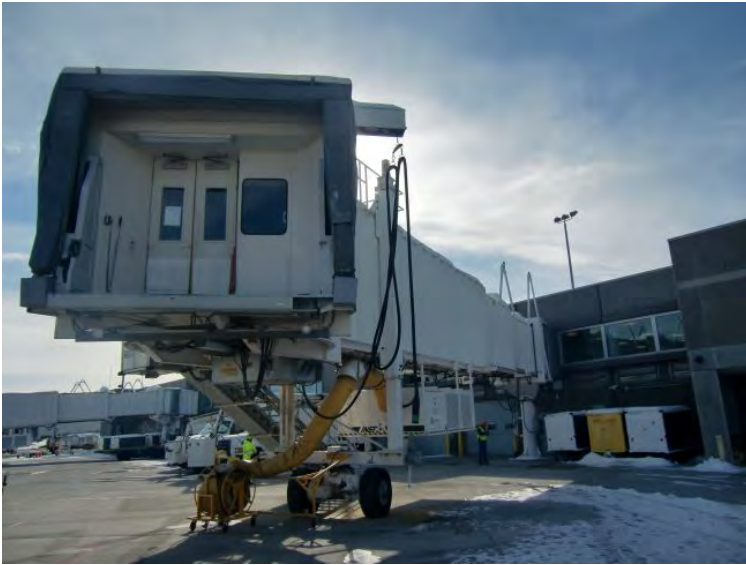
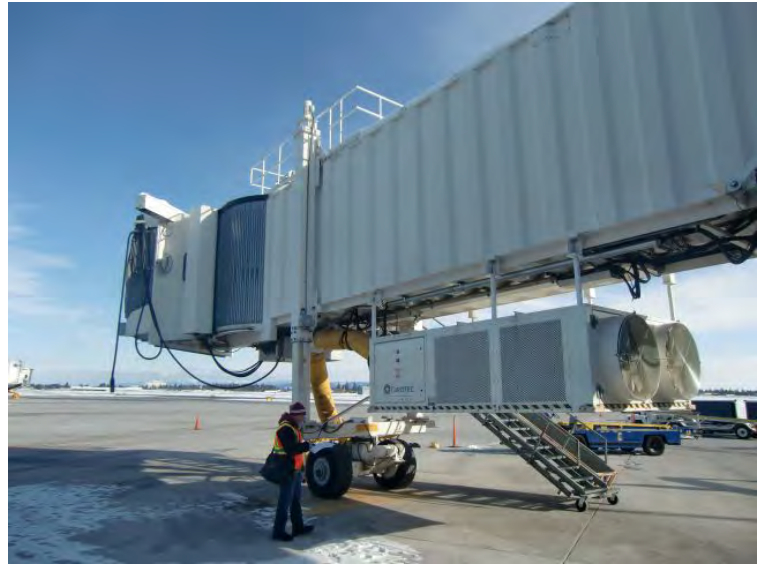
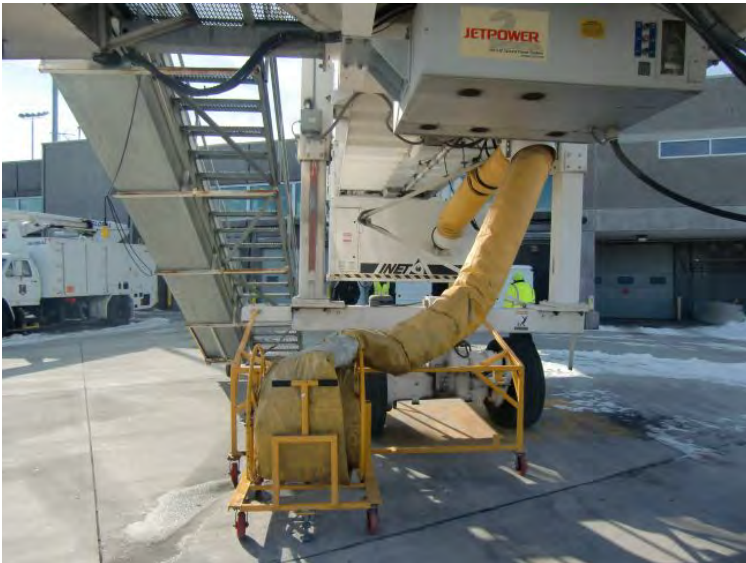
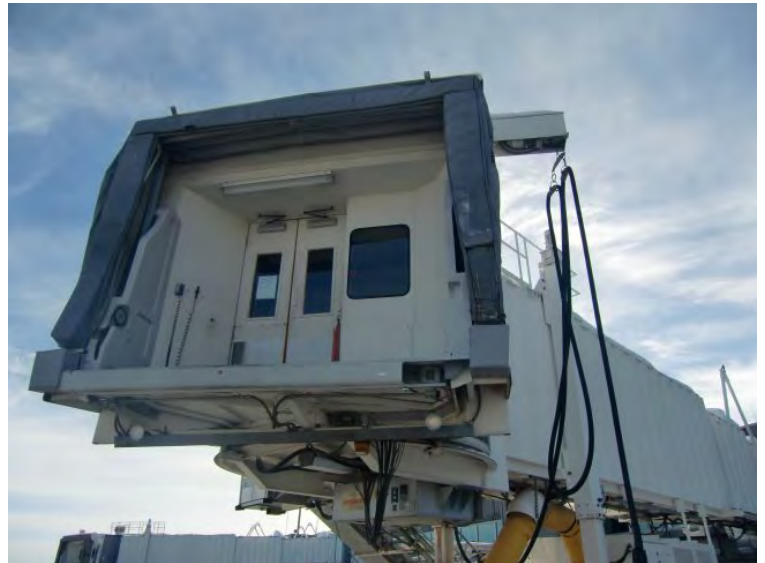
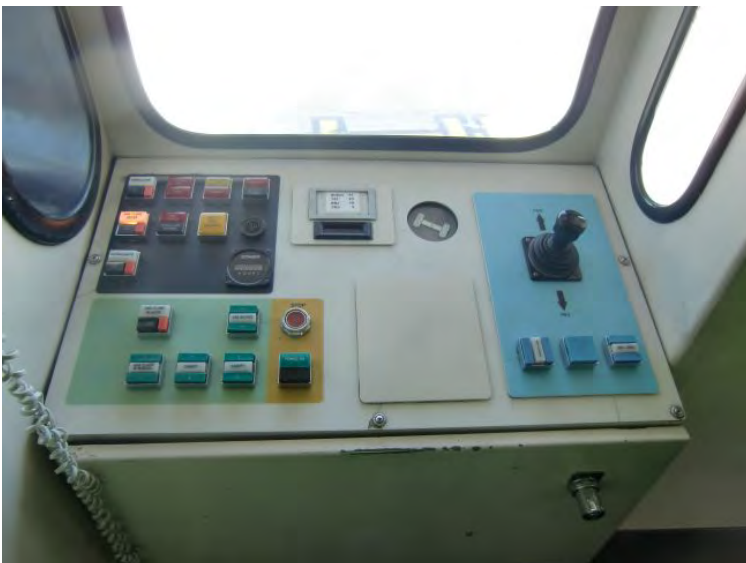
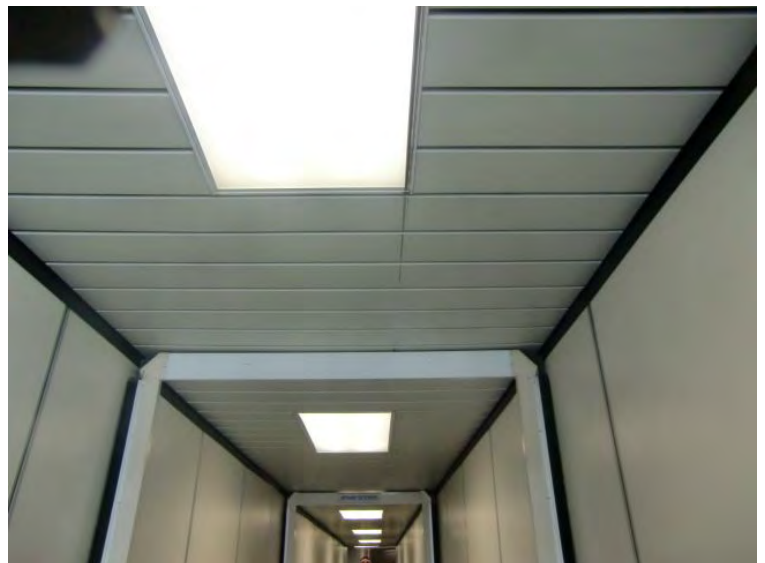
Gate 1

Chalking of the exterior paint is present throughout the exterior surfaces of the bridge. Interior paint is in fair to poor condition. The cab and bubble floor ribbed rubber is worn. B tunnel wall

panels exhibit signs of water infiltration and are beginning to swell on the bottom. The carpet needs to be replaced due to staining.

The light diffuser in the rotunda fixture is broken. The console faceplate has numerous cracks.

Tunnel rollers are out of alignment with a few potentially bad bearings. The vertical lift columns appear to be slightly out of rack. The equalizer cable is rusting. There are small holes in the canopy.

This passenger boarding bridge is 24 years old and is in overall “fair” condition. This PBB meets NFPA 415 standards.

Exterior paint requires a pressure wash and touch up paint at a minimum. Cosmetically, the interior paint is in fair condition. Service bulletins appear to have been performed. Most major lubrication points are being addressed.

This PBB is in need of a heavy refurbishment. In the opinion of the ASE staff, with a heavy refurbishment, the life of this PBB could be extended by approximately 8 - 10 years.

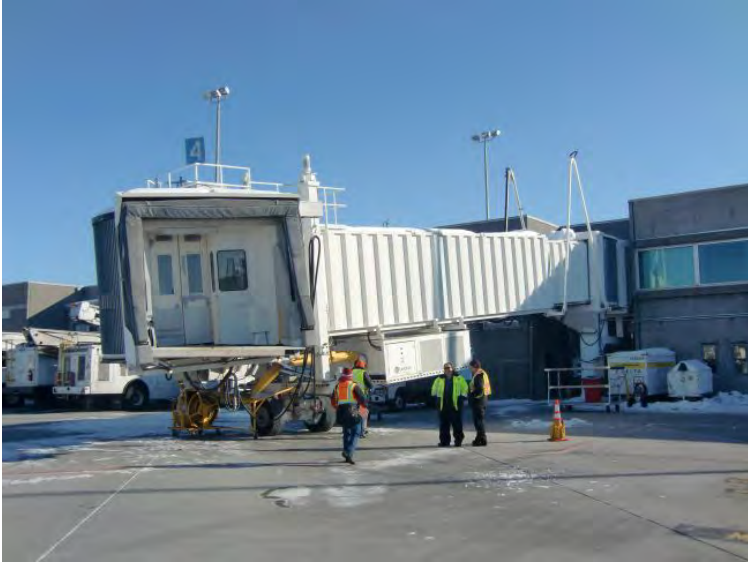
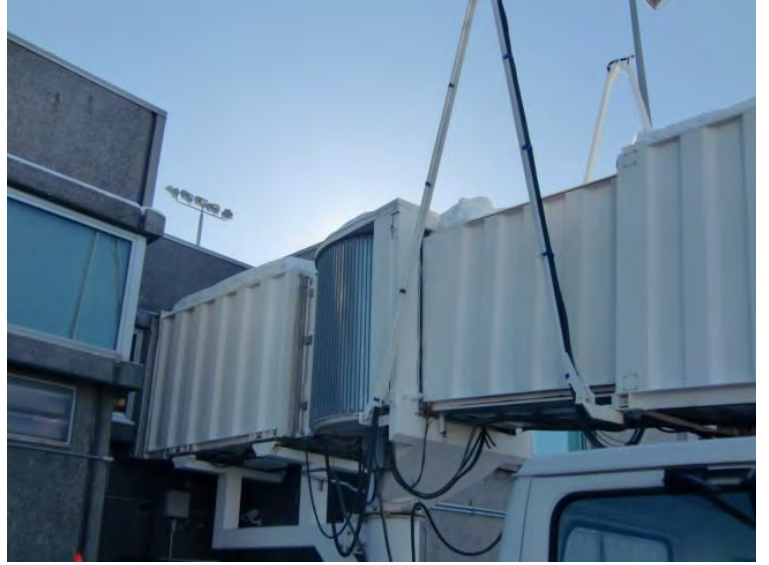
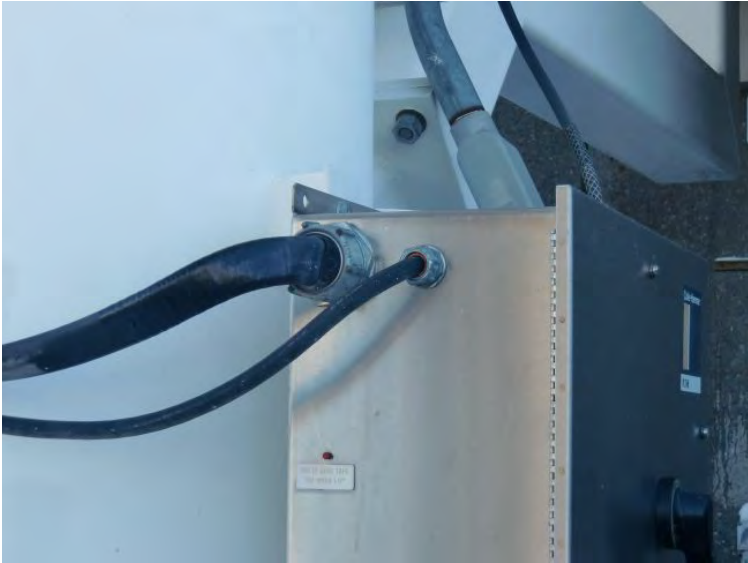
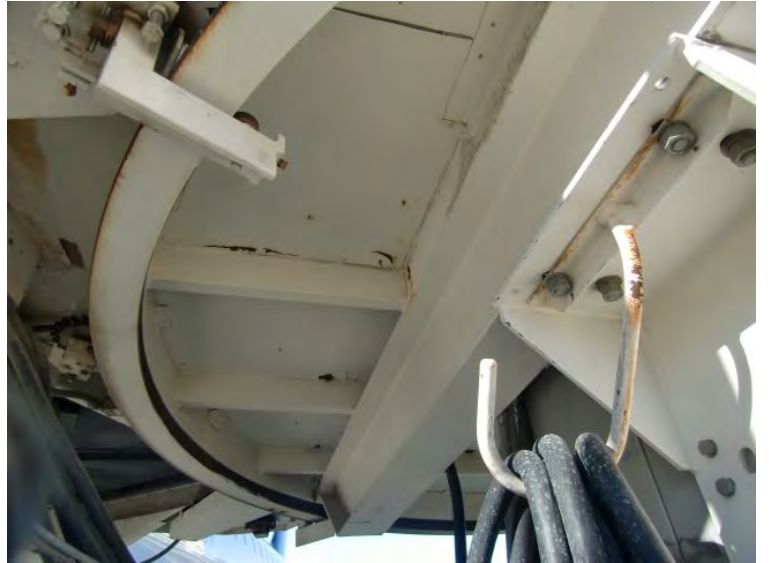
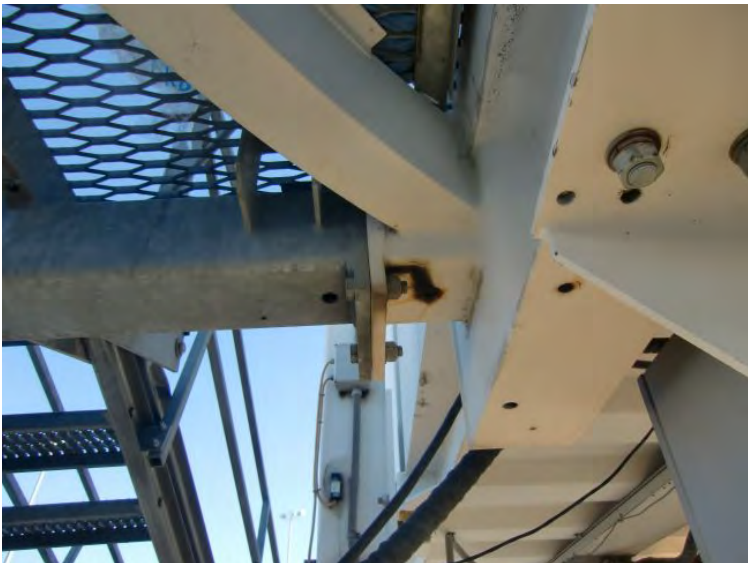
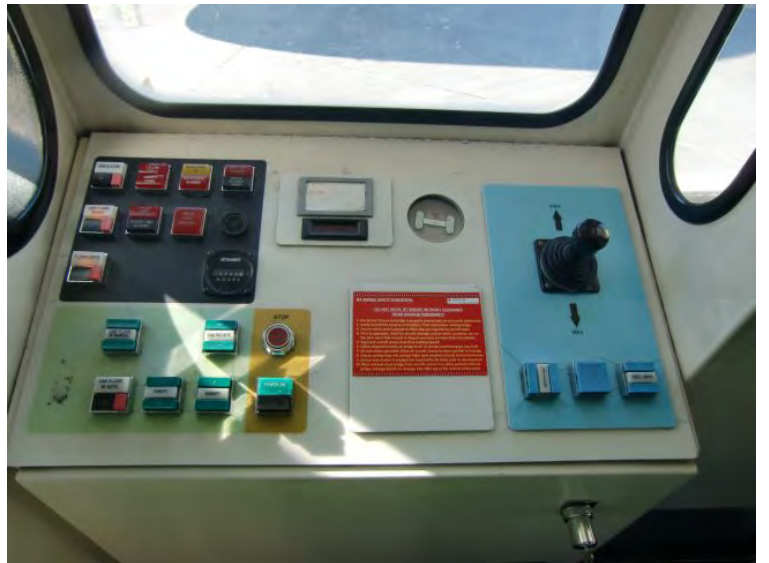
Gate 4

There may be minor stress cracks in the vertical column to baseplate welds.

Chalking of the exterior paint is present throughout the exterior surfaces of the bridge. Interior paint is in fair to poor condition. The cab and bubble floor ribbed rubber is worn. There is minor cab rust under the bubble flooring. The left A tunnel wall panels have water damage. Service door flashing is bent.

The console faceplate has numerous cracks.

The A tunnel transition ramp hinge is broken. One transition ramp handrail on the right side A tunnel is missing. A right side A tunnel end block is loose. Tunnel rollers are noisy indicating an out of alignment situation with a few potentially bad bearings. The rigid frame guide rollers are out of alignment. There are small holes in the canopy. The right side service stair handrail is bent. There appears to be some binding in the ACF actuator.

This passenger boarding bridge is 21 years old and is in overall “fair” condition. This PBB meets NFPA 415 standards.

Exterior paint requires a pressure wash and touch up paint at a minimum. Cosmetically, the interior paint is in fair condition. Service bulletins appear to have been performed. All major lubrication points appear to have been recently serviced.

This PBB is in need of a heavy refurbishment. In the opinion of the ASE staff, with a heavy refurbishment, the life of this PBB could be extended by approximately 8 - 10 years.

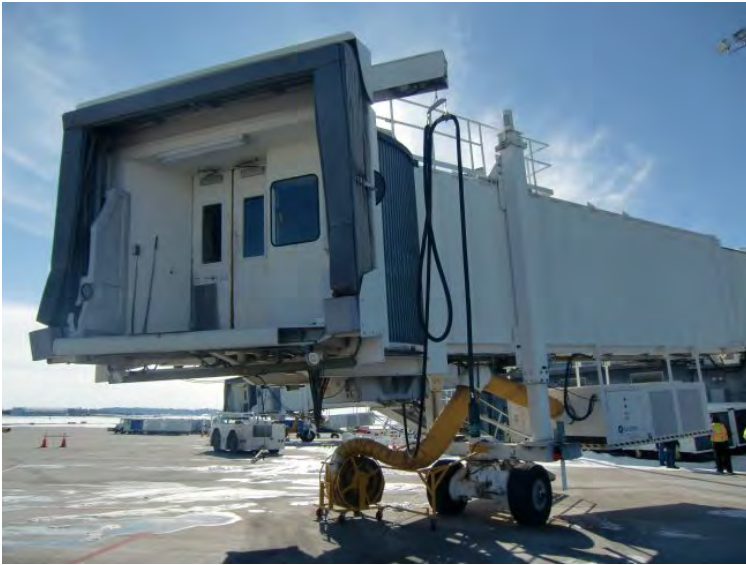
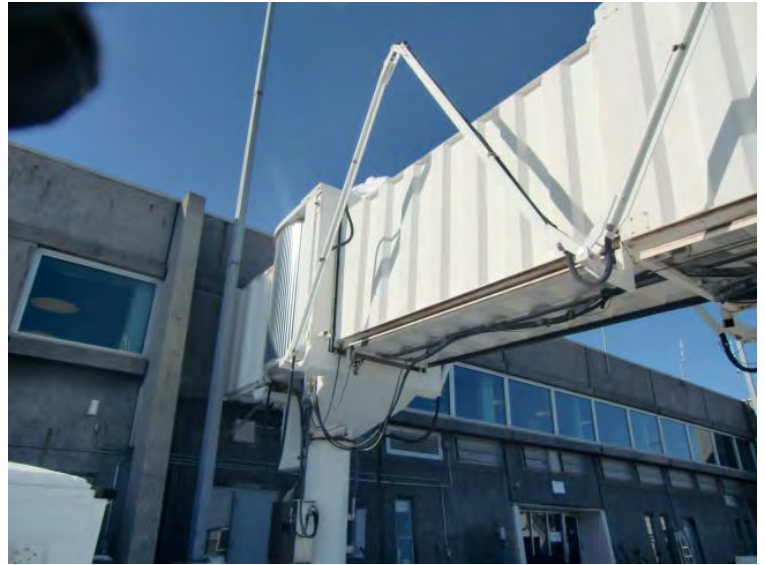
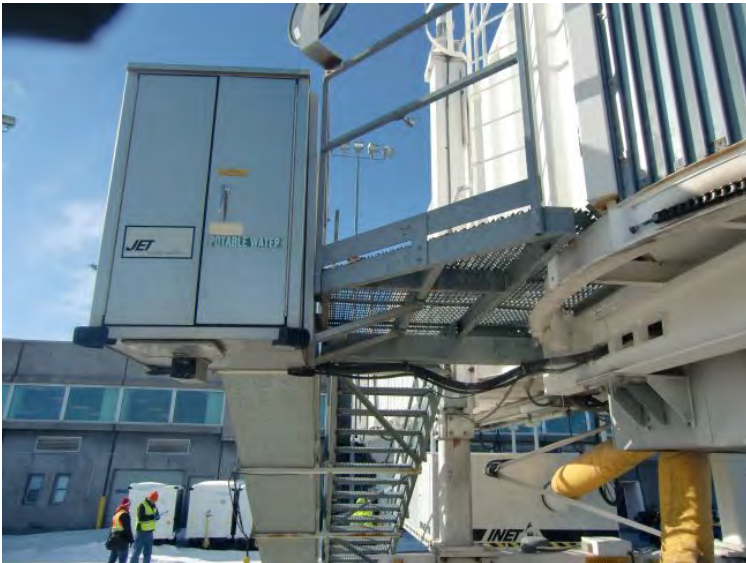
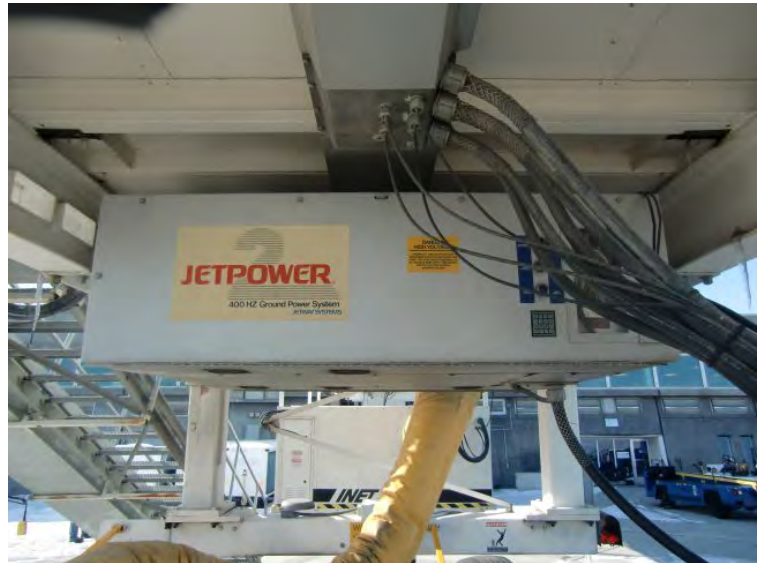
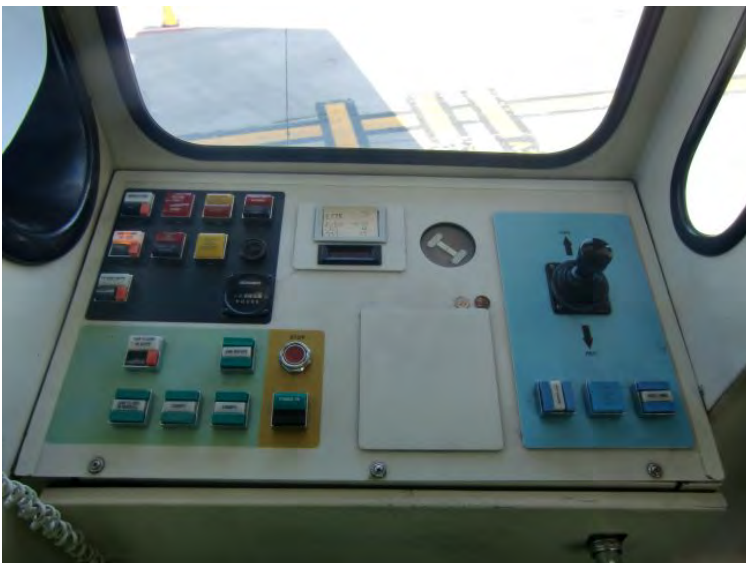
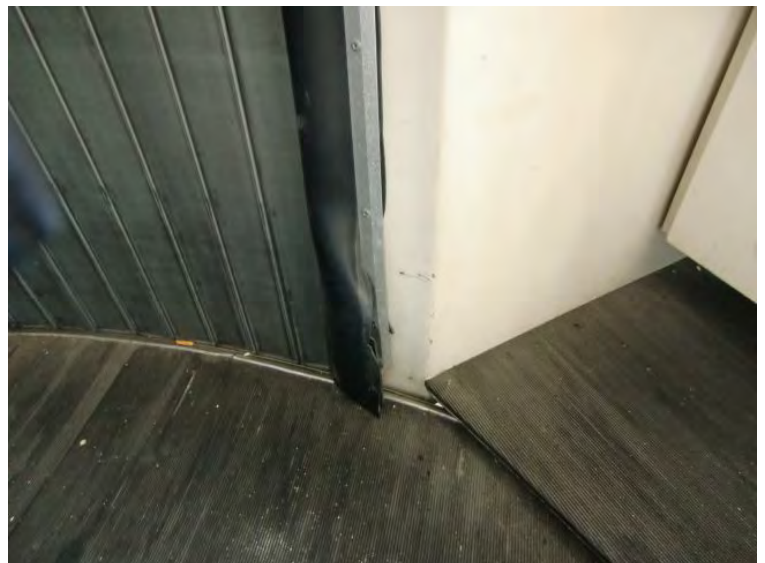
Gate 5

Chalking of the exterior paint is present throughout the exterior surfaces of the bridge. Interior paint is in fair to poor condition. The cab and bubble floor ribbed rubber is worn. C tunnel wall panels have water damage. The left side canopy actuator cover is broken.

The 400 Hz feeder is damaged in the festoon carrier. The console faceplate has numerous cracks. The right canopy actuator brake has failed.

Tunnel rollers are noisy indicating an out of alignment situation with a few potentially bad bearings. Both lower cab rollers should be replaced.

This passenger boarding bridge is 24 years old and is in overall “fair” condition. This PBB meets NFPA 415 standards.

Exterior paint requires a pressure wash and touch up paint at a minimum. Cosmetically, the interior paint is in fair condition. Service bulletins appear to have been performed. All major lubrication points appear to have been recently serviced.

This PBB is in need of a heavy refurbishment. In the opinion of the ASE staff, with a heavy refurbishment, the life of this PBB could be extended by approximately 8 - 10 years.

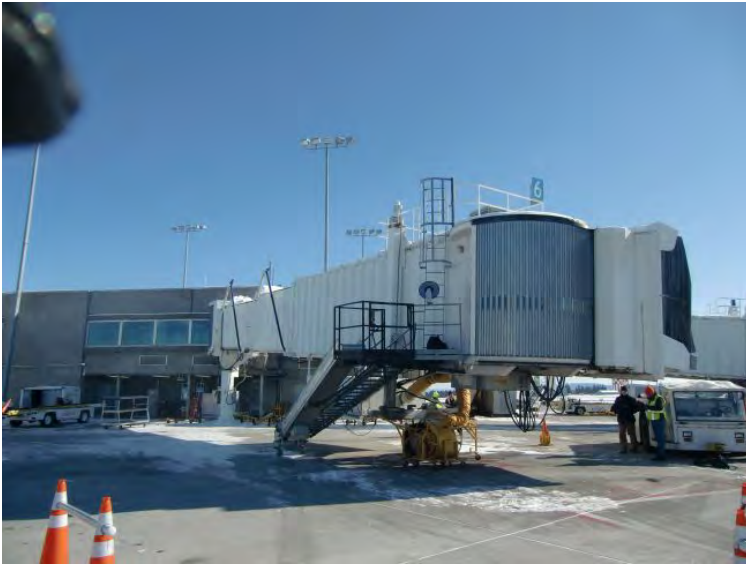
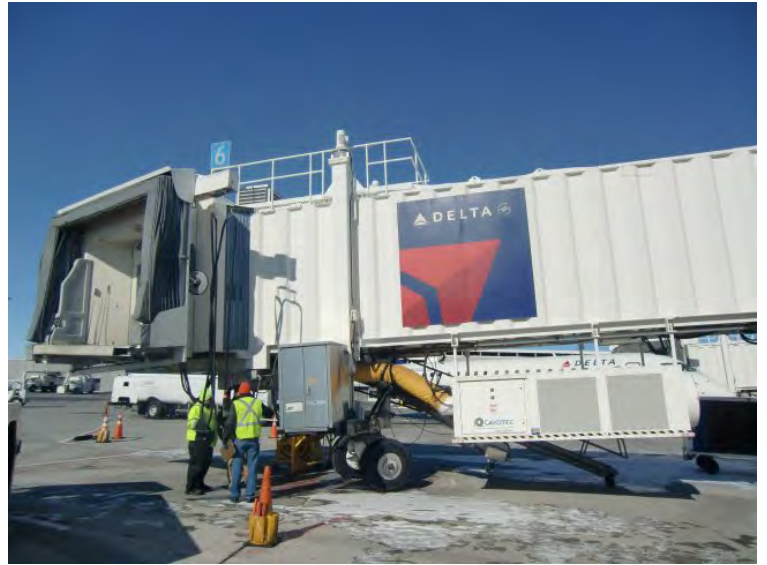
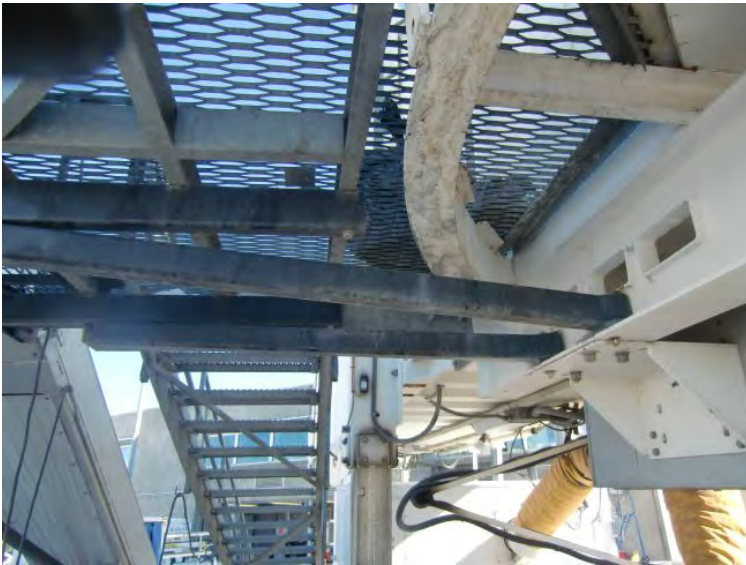
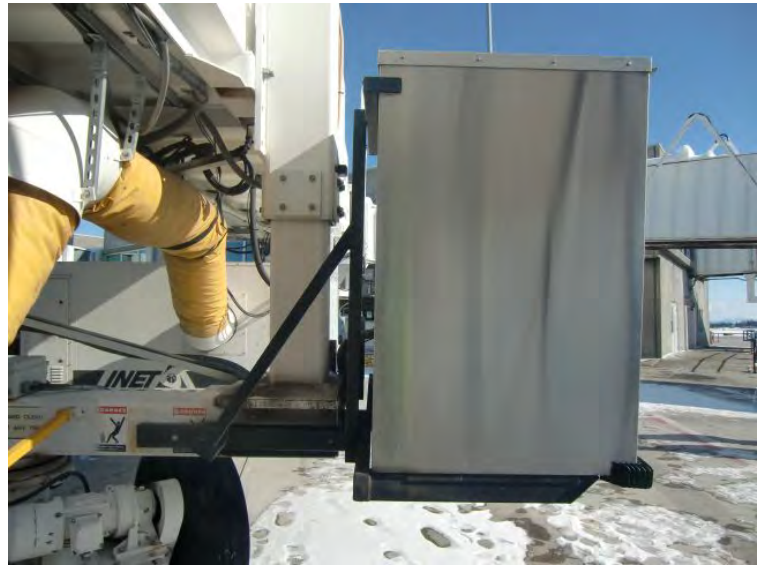
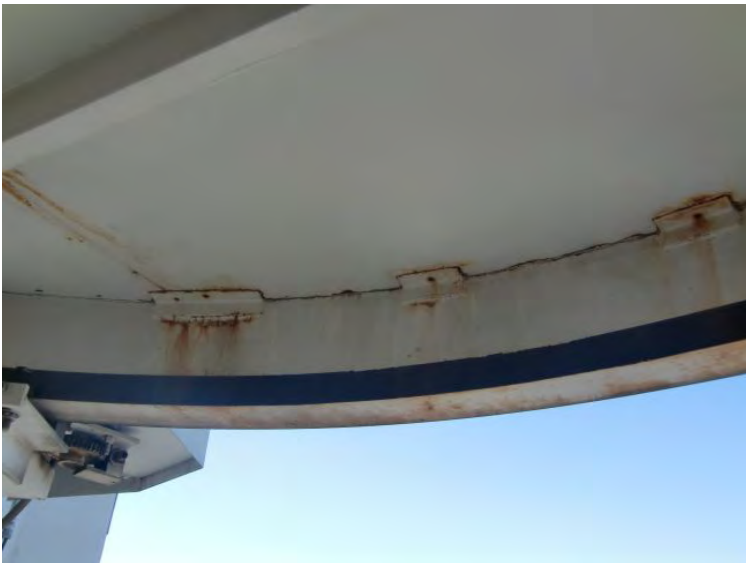
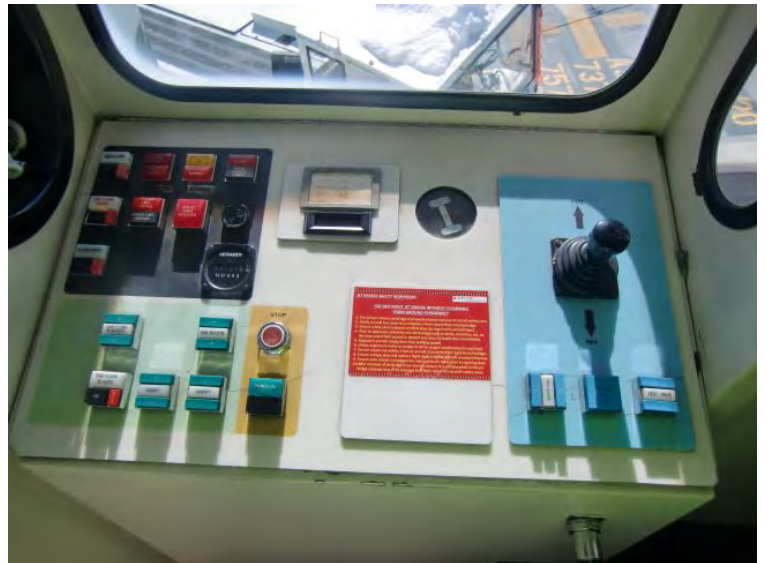
Gate 6

Chalking of the exterior paint is present throughout the exterior surfaces of the bridge. Interior paint is in fair to poor condition. The cab and bubble floor ribbed rubber is worn. A portion of carpet trim is broken on the Rotunda radius. There is minor cab rust. Most wall panels exhibit signs of water infiltration and are beginning to swell on the bottom.

Tunnel rollers are noisy indicating an out of alignment situation with a few potentially bad bearings. The rigid frame guide rollers are out of alignment. There are small holes in the canopy. The equalizer cable is loose. The rotunda roof should be leveled.

This passenger boarding bridge is 21 years old and is in overall “fair” condition. This PBB meets NFPA 415 standards.

Exterior paint requires a pressure wash and touch up paint at a minimum. Cosmetically, the interior paint is in fair condition. Service bulletins appear to have been performed. All major lubrication points appear to have been recently serviced. The left rotunda curtain needs tensioning.

This PBB is in need of a heavy refurbishment. In the opinion of the ASE staff, with a heavy refurbishment, the life of this PBB could be extended by approximately 8 - 10 years.

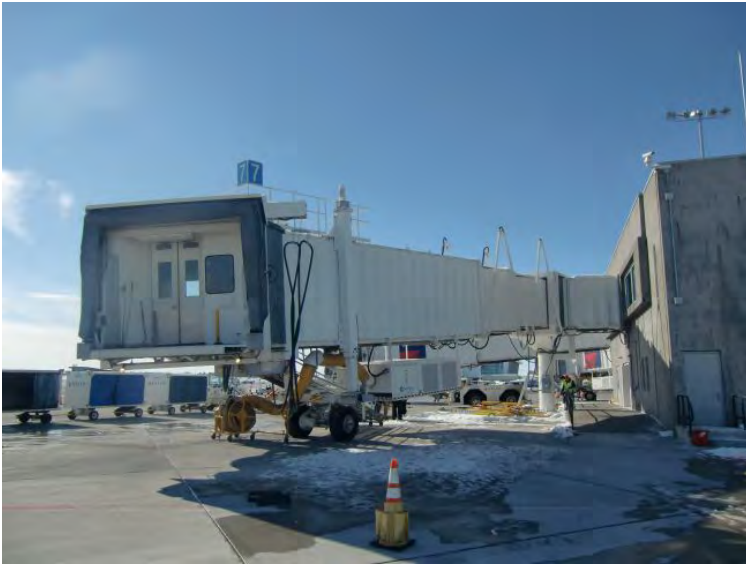
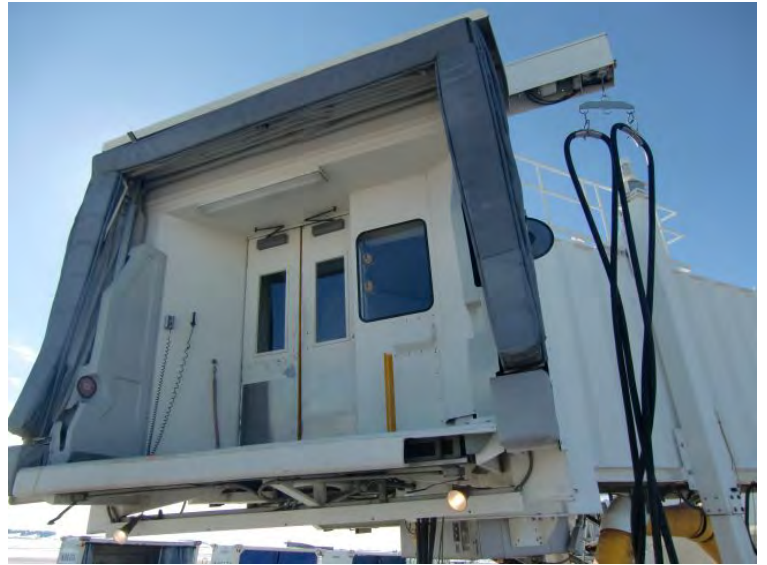
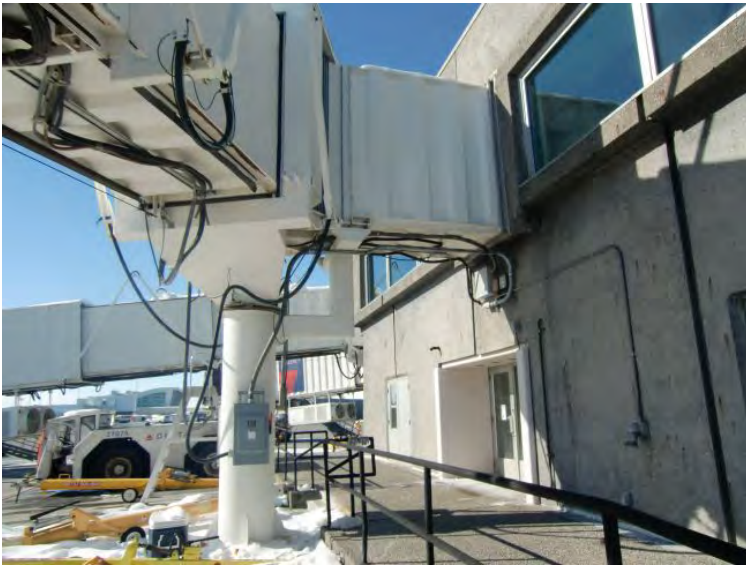
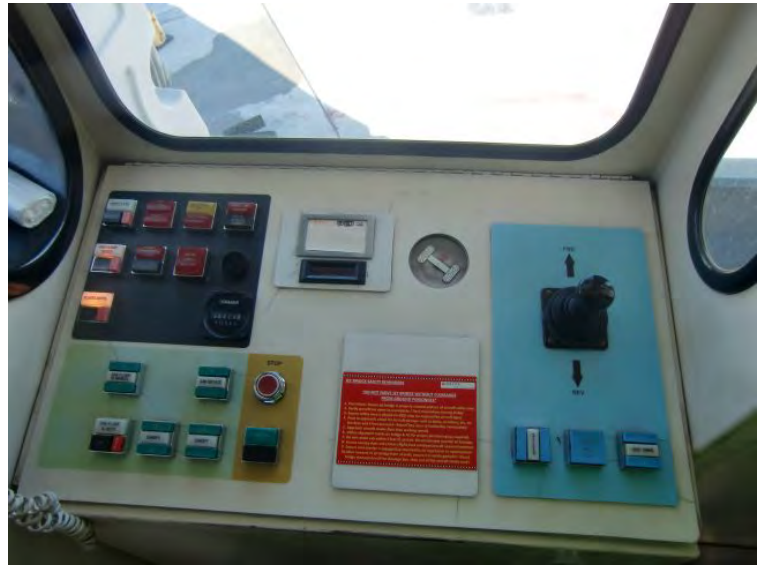
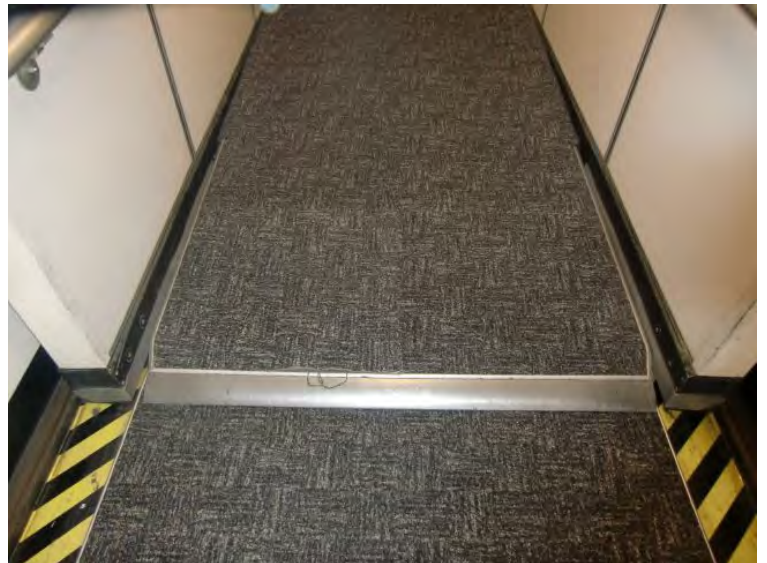
Gate 7

Chalking of the exterior paint is present throughout the exterior surfaces of the bridge. Interior paint is in fair to poor condition. The cab and bubble floor ribbed rubber is worn. There are screw holes in 4 wall panels. Rips in the A tunnel carpet are evident.

The console faceplate has numerous cracks.

This passenger boarding bridge is 21 years old and is in overall “fair” condition. This PBB meets NFPA 415 standards.

Exterior paint requires a pressure wash and touch up paint at a minimum. Cosmetically, the interior paint is in fair condition. Service bulletins appear to have been performed. All major lubrication points appear to have been recently serviced.

This PBB is in need of a heavy refurbishment. In the opinion of the ASE staff, with a heavy refurbishment, the life of this PBB could be extended by approximately 8 - 10 years.

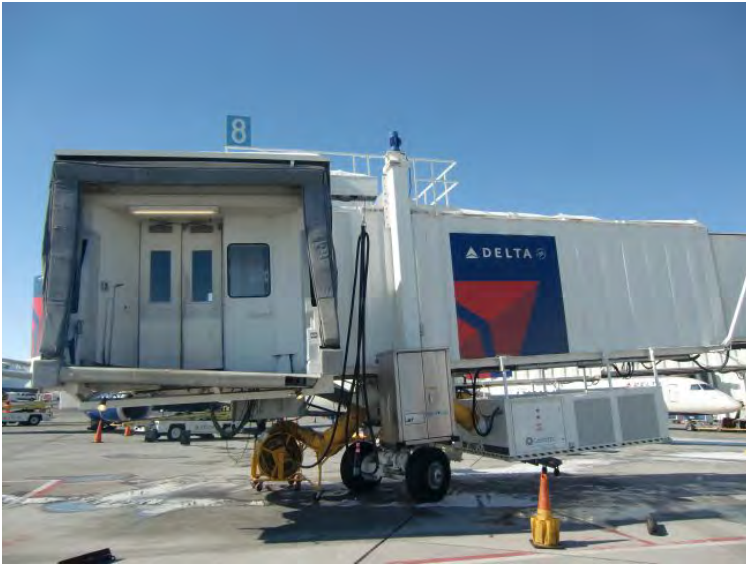
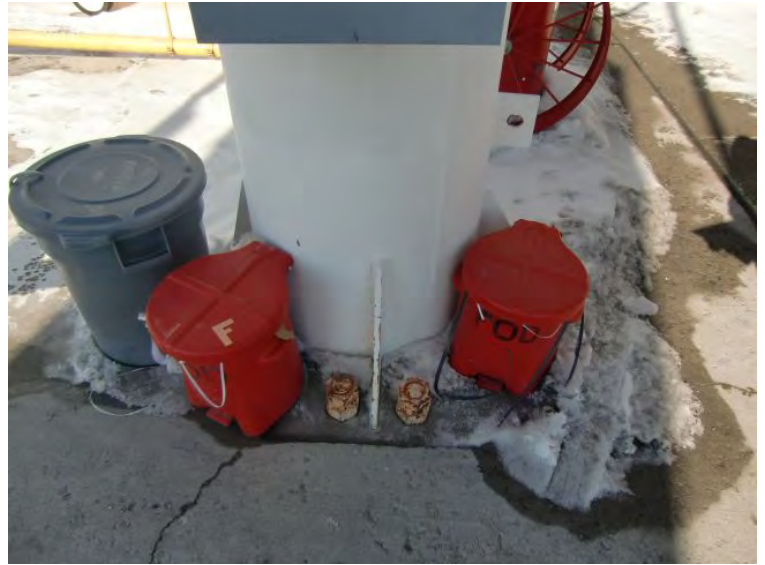
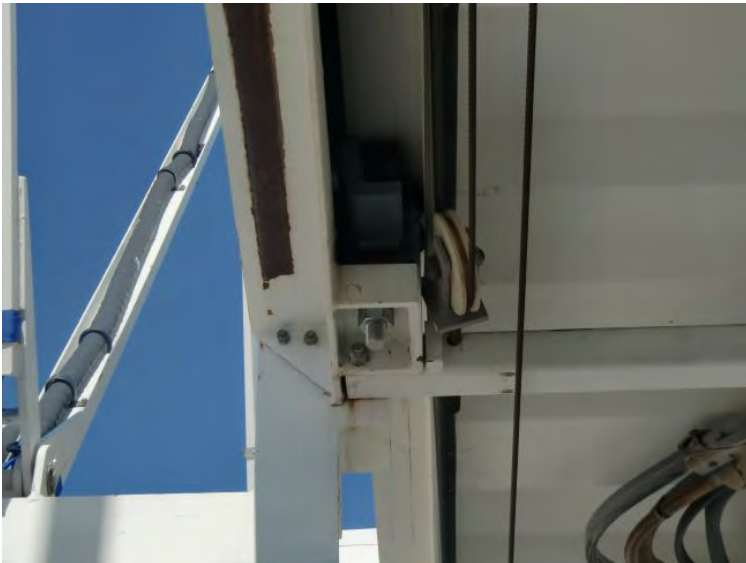
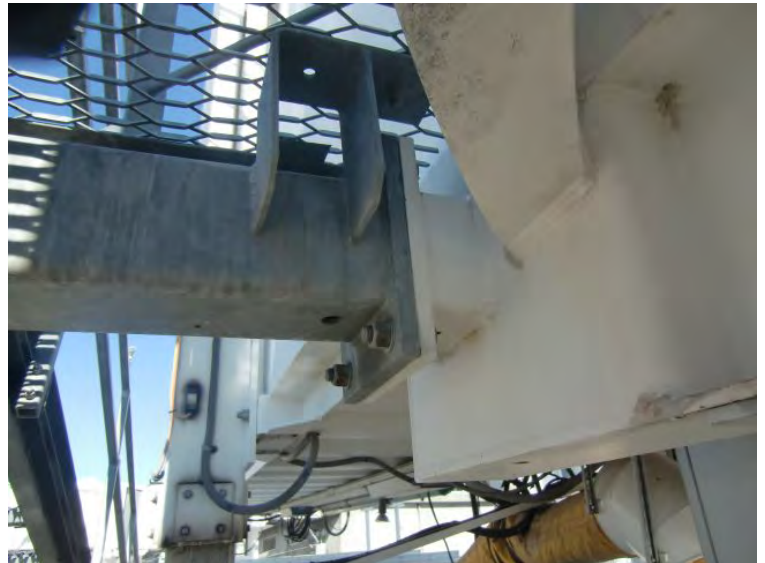
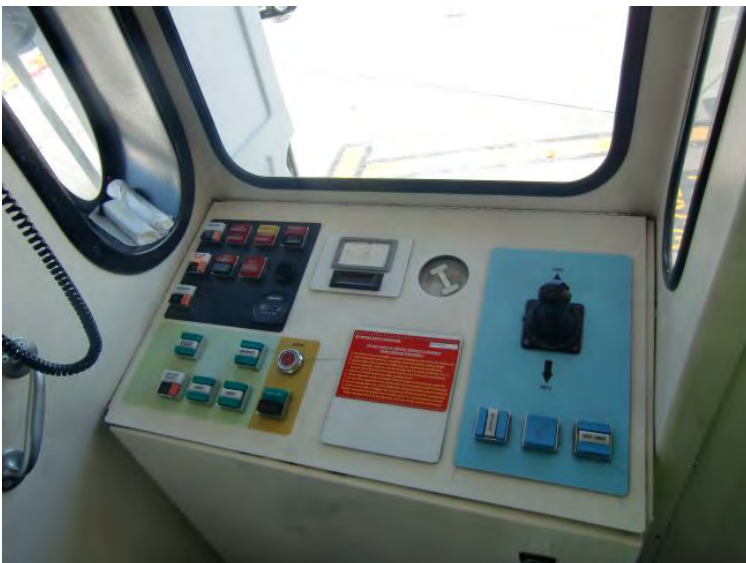
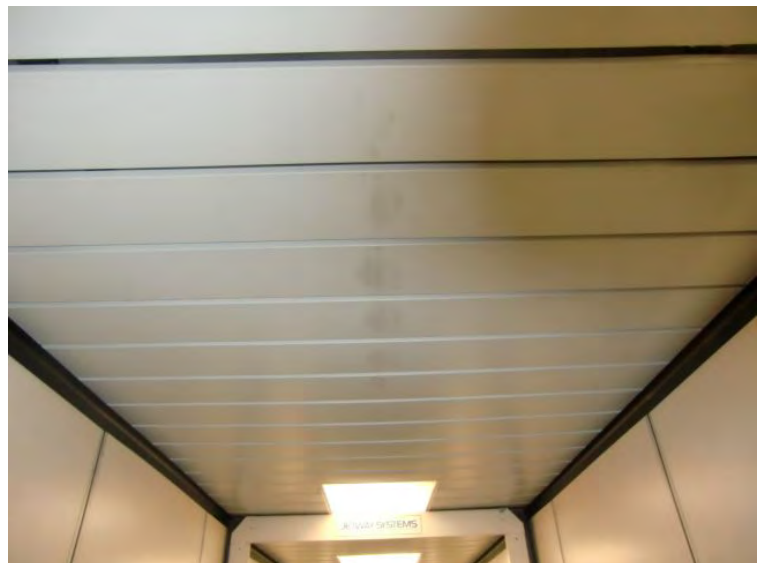
Gate 8

Chalking of the exterior paint is present throughout the exterior surfaces of the bridge. Interior paint is in fair to poor condition. The cab and bubble floor ribbed rubber is worn. A portion of carpet trim is broken on the Rotunda radius. There is minor cab rust. Most wall panels exhibit signs of water infiltration and are beginning to swell on the bottom. The service door window is cracked. Multiple ceiling tiles are scraped from improper roller adjustment. The right canopy actuator cover is cracked. The floor sweep on the saloon doors is ripped.

The console faceplate has numerous cracks. There is a delay in the steering function.

Tunnel rollers are noisy indicating an out of alignment situation with a few potentially bad bearings. The rigid frame guide rollers are out of alignment. There are small holes in the canopy. A left side service stair handrail is bent. The cab rotate chain is too loose.

This passenger boarding bridge is 21 years old and is in overall “fair” condition. This PBB meets NFPA 415 standards.

Exterior paint requires a pressure wash and touch up paint at a minimum. Cosmetically, the interior paint is in fair condition. Service bulletins appear to have been performed. All major lubrication points appear to have been recently serviced.

This PBB is in need of a heavy refurbishment. In the opinion of the ASE staff, with a heavy refurbishment, the life of this PBB could be extended by approximately 8 - 10 years.

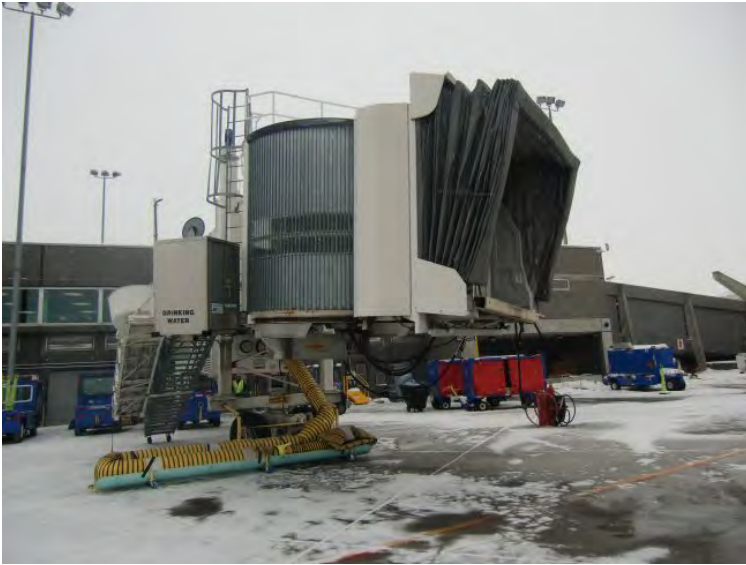
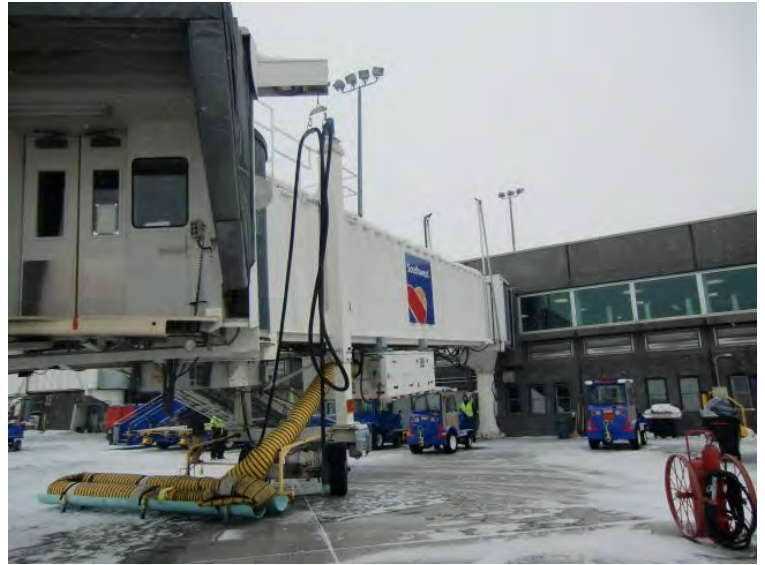
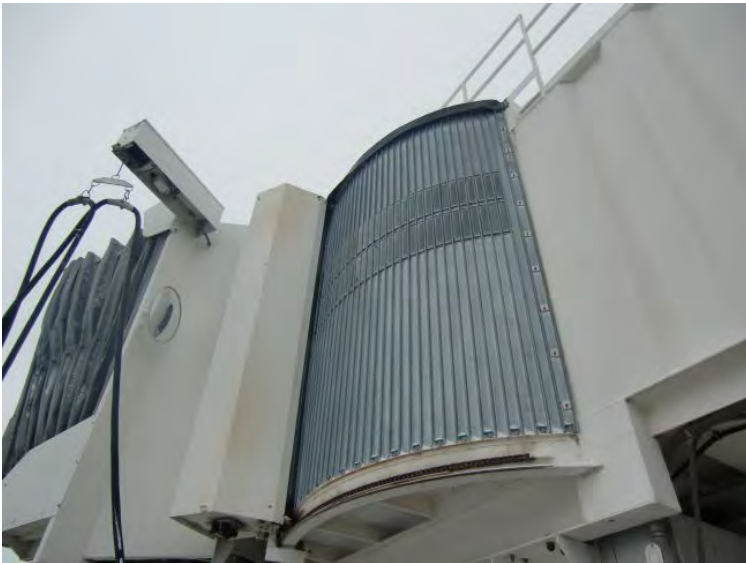
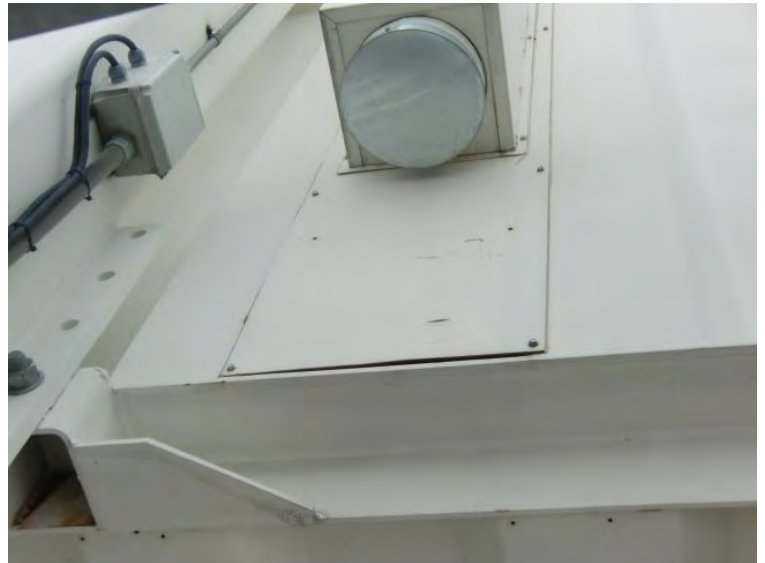
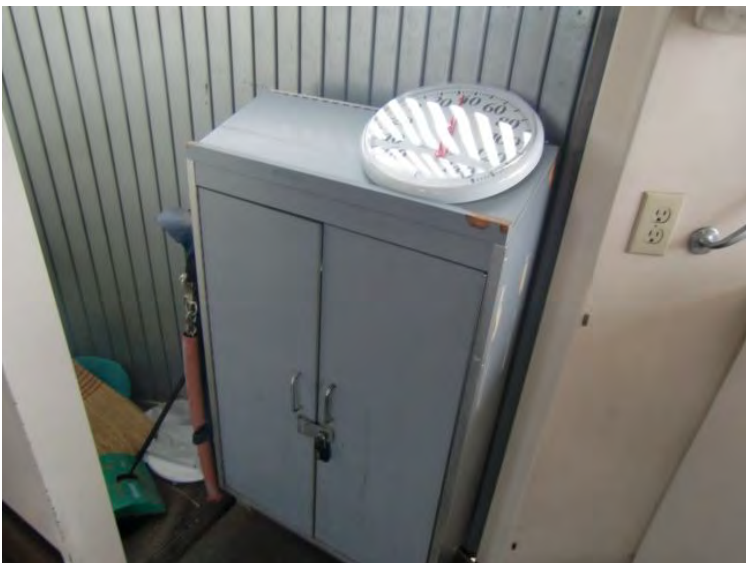
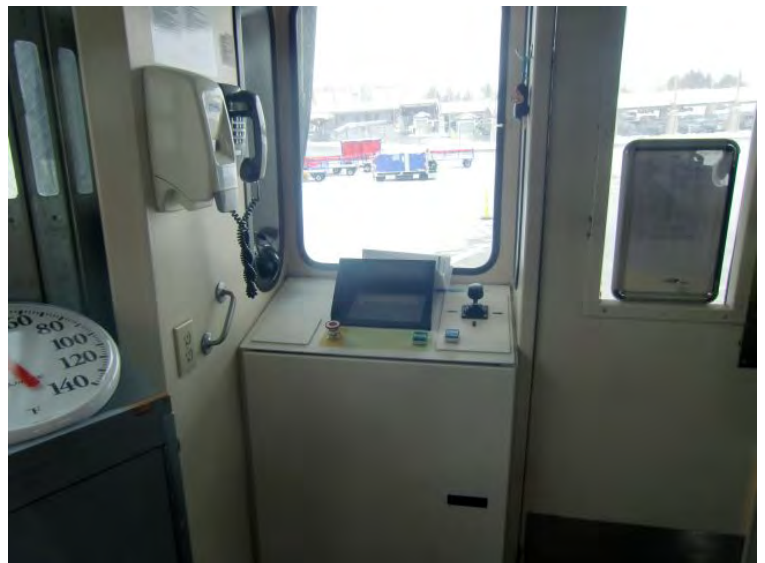
Gate 11

Minor rust under cab bubble floor.

Chalking of the exterior paint is present throughout the exterior surfaces of the bridge. Interior paint is in fair to poor condition. The cab and bubble floor ribbed rubber is worn. Wall panels are

scuffed with some water damage. Tunnel roller access covers need to be reinstalled under C tunnel.

This passenger boarding bridge is 21 years old and is in overall “fair” condition. This PBB meets NFPA 415 standards.

Exterior paint requires a pressure wash and touch up paint at a minimum. Cosmetically, the interior paint is in fair condition. Service bulletins appear to have been performed. All major lubrication points appear to have been recently serviced.

This PBB is in need of a Moderate refurbishment. In the opinion of the ASE staff, with a moderate refurbishment, the life of this PBB could be extended by approximately 8 - 10 years.

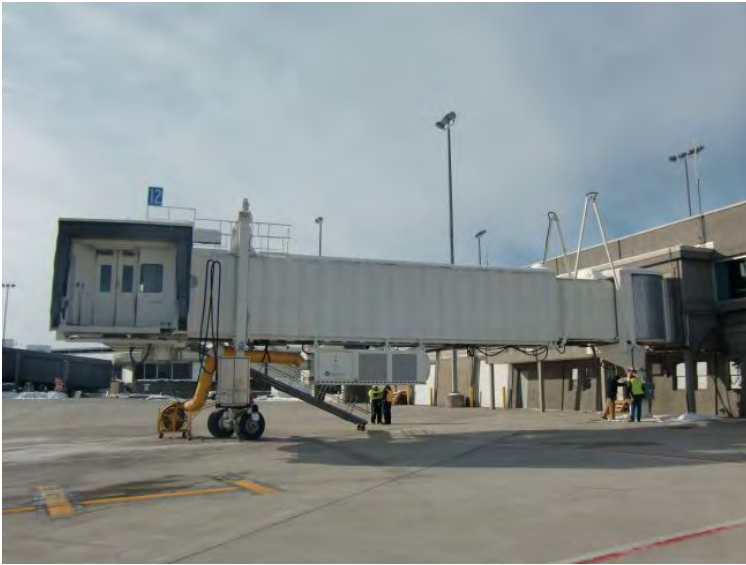
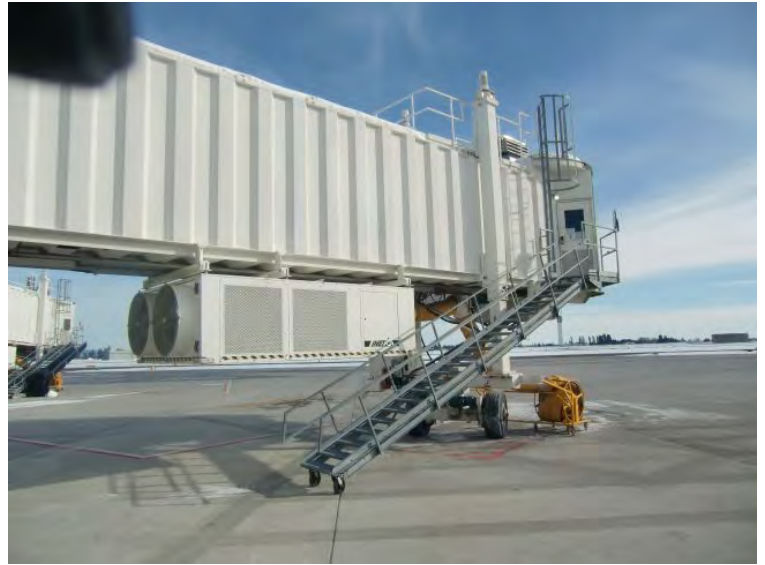
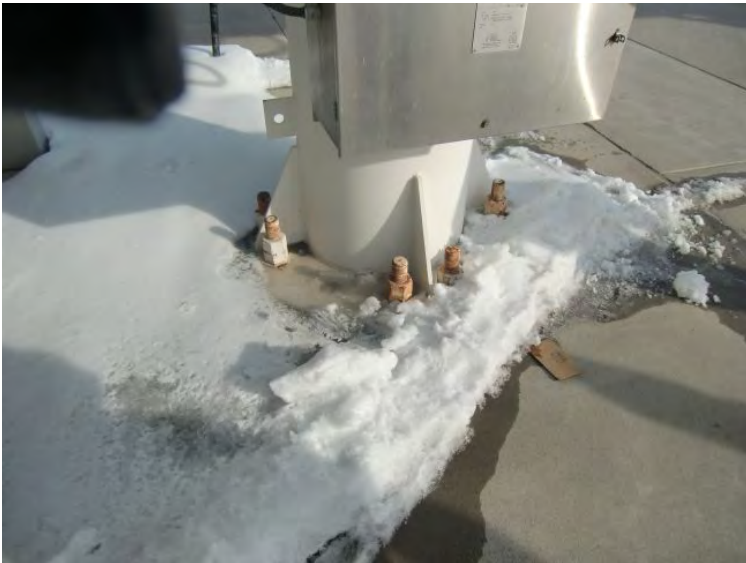
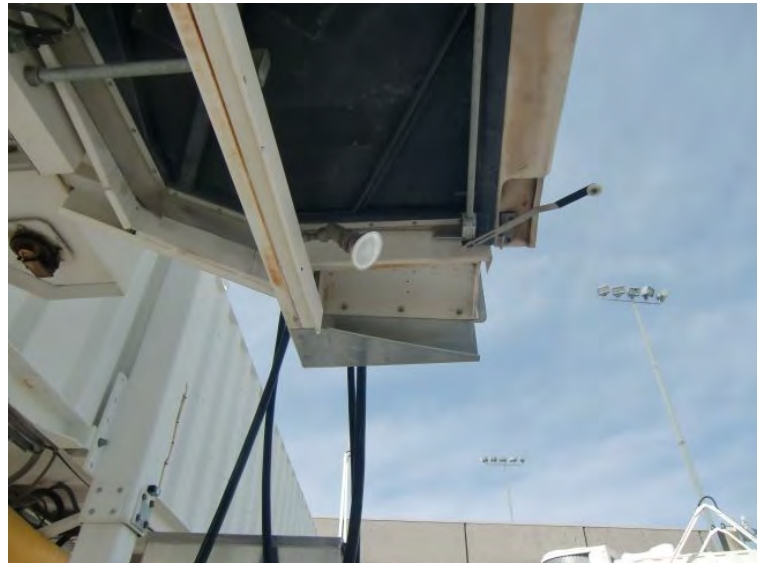
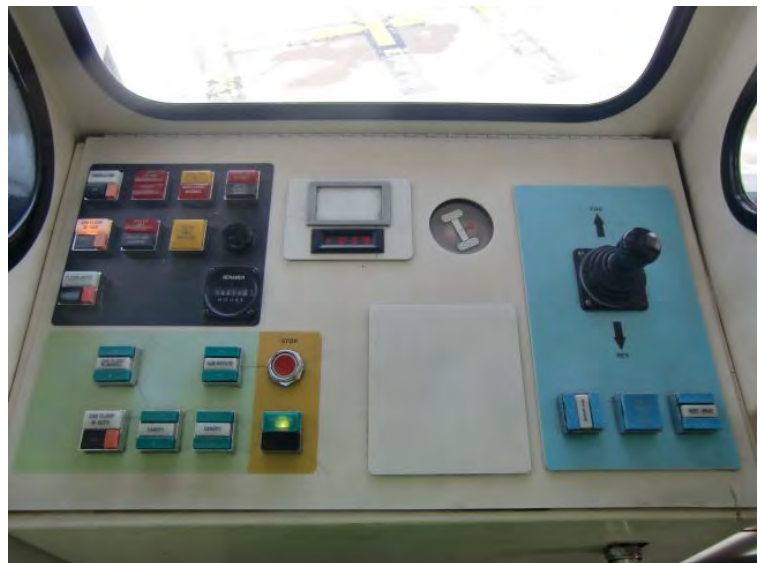
Gate 12

Chalking of the exterior paint is present throughout the exterior surfaces of the bridge. Interior paint is in fair to poor condition. The cab and bubble floor ribbed rubber is worn. There is minor rusting of the firepan under the cab.

The console faceplate has numerous cracks.

This passenger boarding bridge is 21 years old and is in overall “fair” condition. This PBB meets NFPA 415 standards.

Exterior paint requires a pressure wash and touch up paint at a minimum. Cosmetically, the interior paint is in fair condition. Service bulletins appear to have been performed. All major lubrication points appear to have been recently serviced.

This PBB is in need of a heavy refurbishment. In the opinion of the ASE staff, with a heavy refurbishment, the life of this PBB could be extended by approximately 8 - 10 years.
