SPOKANE INTERNATIONAL AIRPORT PASSENGER BOARDING BRIDGE CONDITION ASSESSMENT

SPOKANE INTERNATIONAL AIRPORT

AERO SYSTEMS ENGINEERING, INC.

ASE PROJECT NO.:
118716GEGGEG

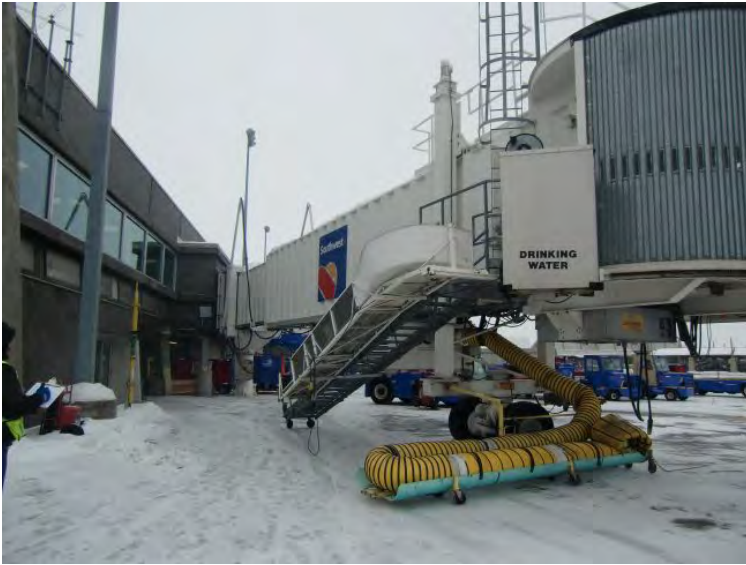
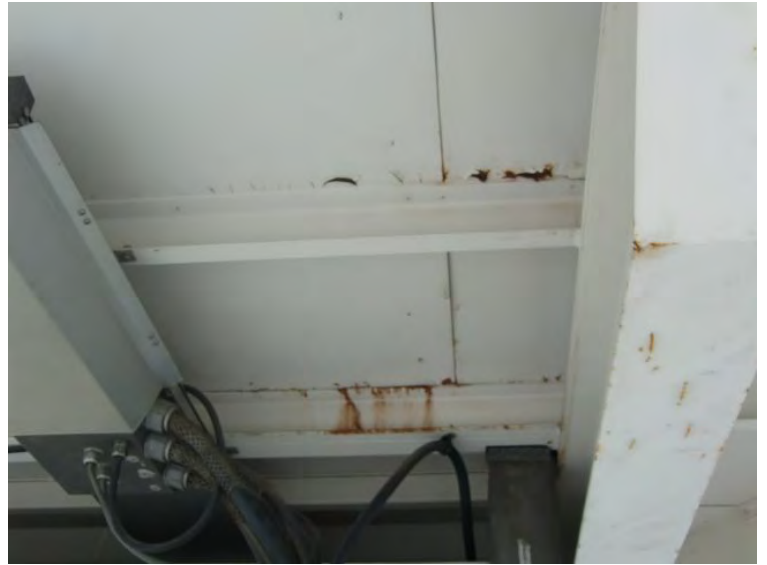
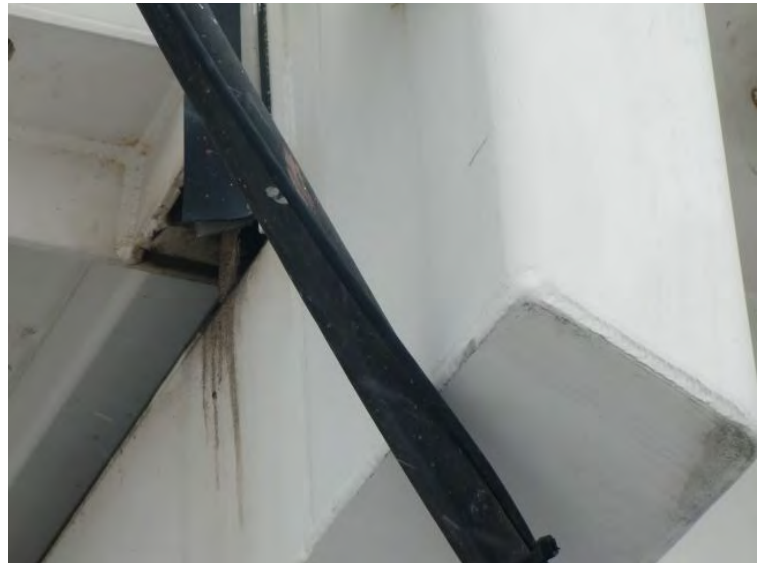
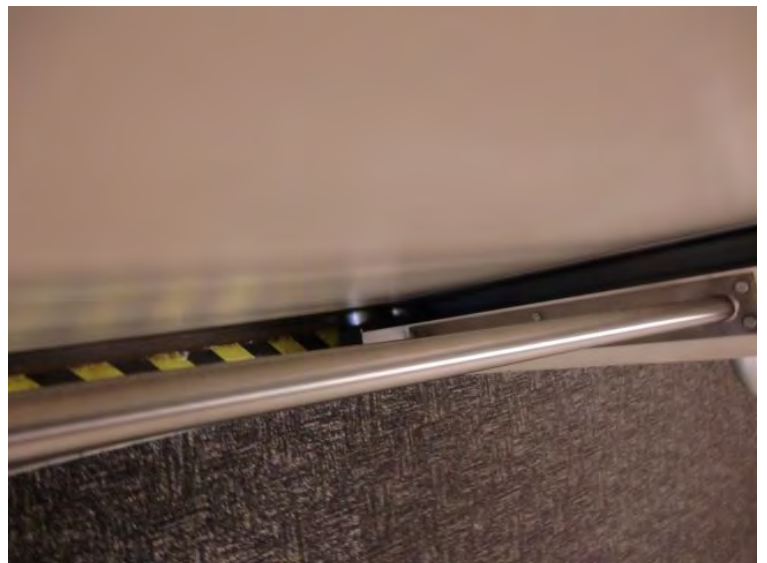
Gate 13

The right vertical lift column shows some stress cracks from previous racking.

Chalking of the exterior paint is present throughout the exterior surfaces of the bridge. Interior paint is in fair to poor condition. The cab and bubble floor ribbed rubber is worn. Tunnel roller access covers need to be reinstalled under C tunnel. Wall panels are scuffed. One ceiling tile is damaged.

This passenger boarding bridge is 21 years old and is in overall “fair” condition. This PBB meets NFPA 415 standards.

Exterior paint requires a pressure wash and touch up paint at a minimum. Cosmetically, the interior paint is in fair condition. Service bulletins appear to have been performed. All major lubrication points appear to have been recently serviced.

This PBB is in need of a heavy refurbishment. In the opinion of the ASE staff, with a heavy refurbishment, the life of this PBB could be extended by approximately 8 - 10 years.

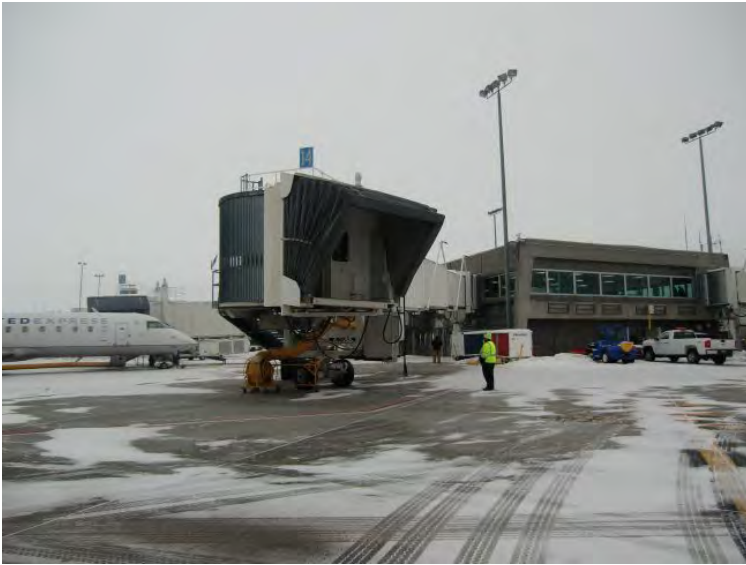
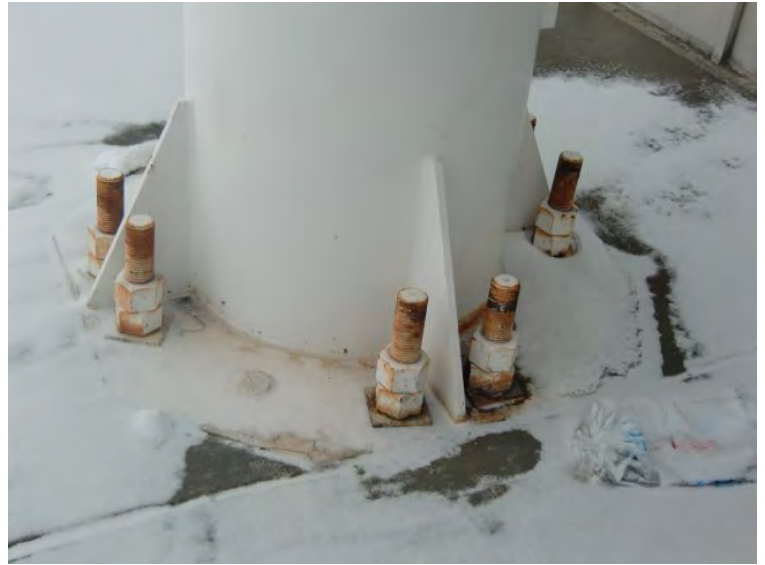
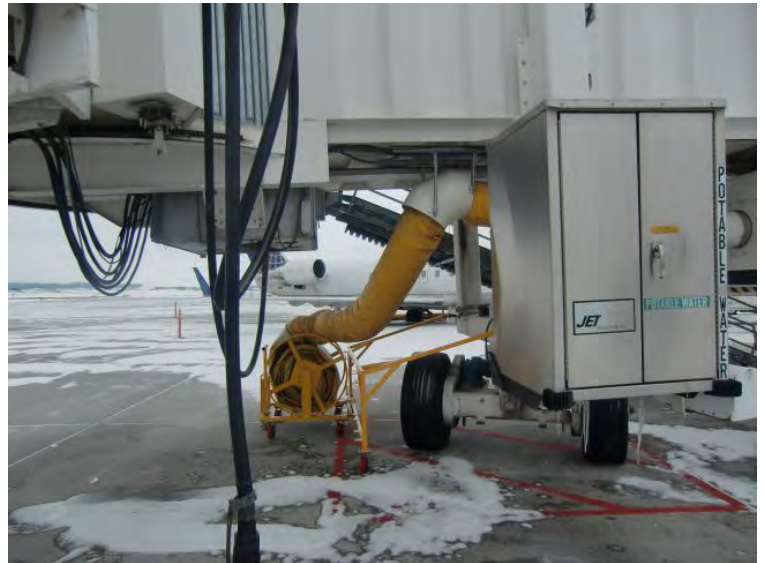
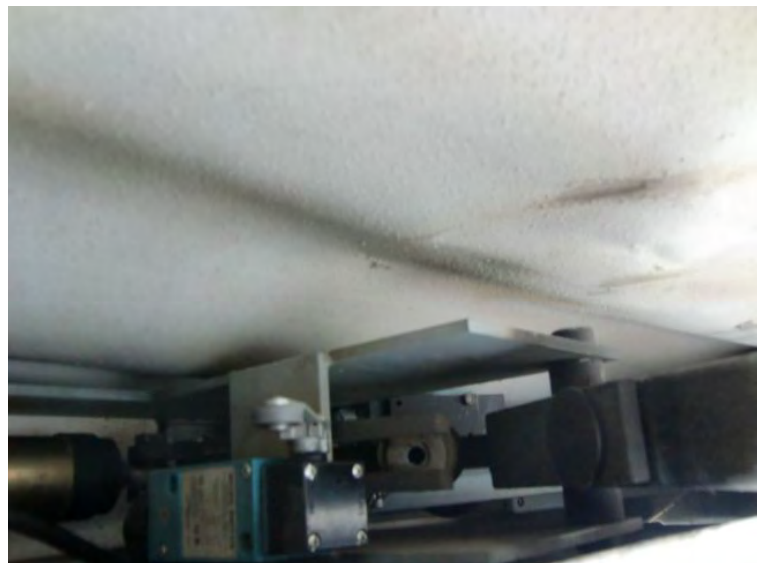
Gate 14

The rotunda baseplate is covered in concrete. There are possible stress cracks in the right vertical lift column baseplate.

Chalking of the exterior paint is present throughout the exterior surfaces of the bridge. Interior paint is in fair to poor condition. The cab and bubble floor ribbed rubber is worn. There is minor cab rust. Most wall panels exhibit signs of water infiltration and are beginning to swell on the bottom. The interior flashing to the building is too tight/bending.

This passenger boarding bridge is 21 years old and is in overall “fair” condition. This PBB meets NFPA 415 standards.

Exterior paint requires a pressure wash and touch up paint at a minimum. Cosmetically, the interior paint is in fair condition. Service bulletins appear to have been performed. All major lubrication points appear to have been recently serviced.

This PBB is in need of a moderate refurbishment. In the opinion of the ASE staff, with a moderate refurbishment, the life of this PBB could be extended by approximately 8 - 10 years.

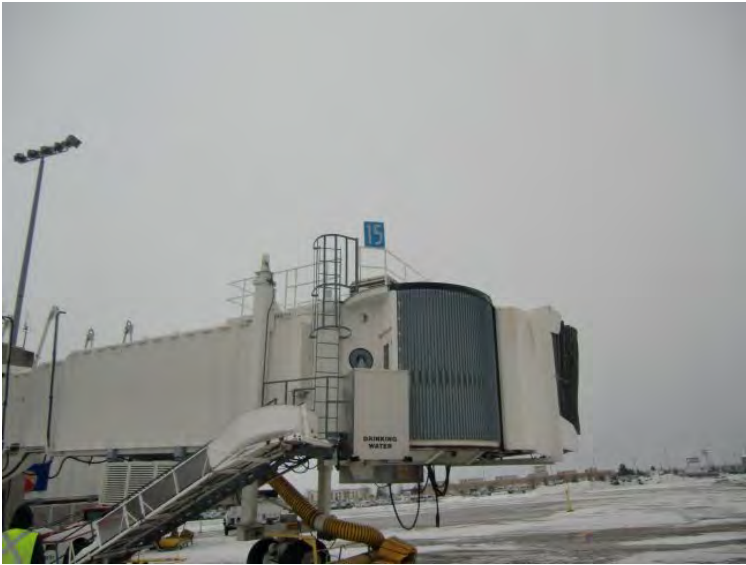
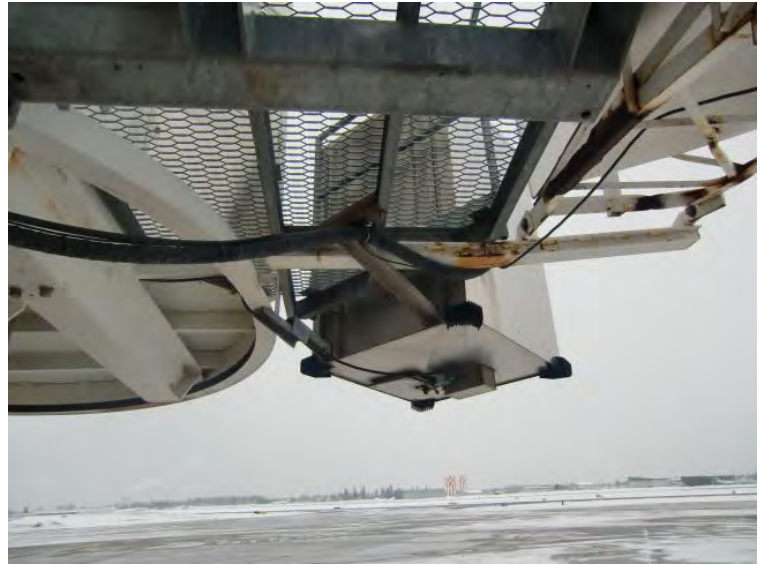
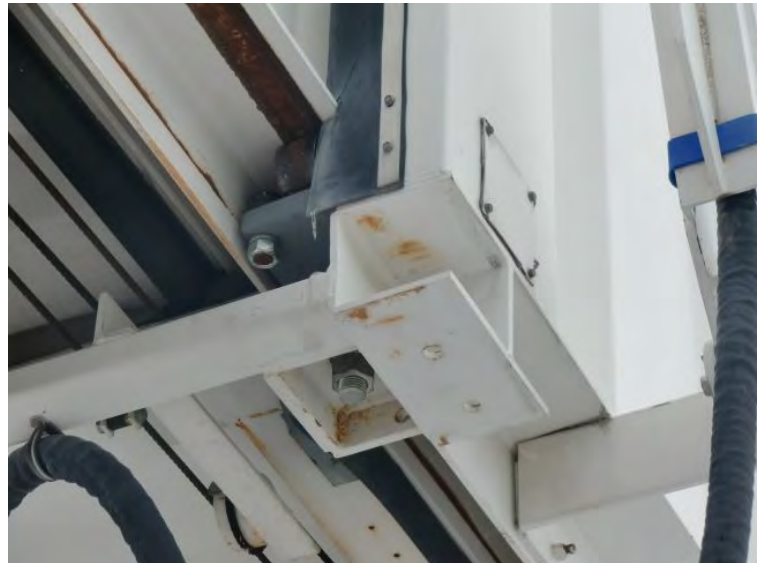
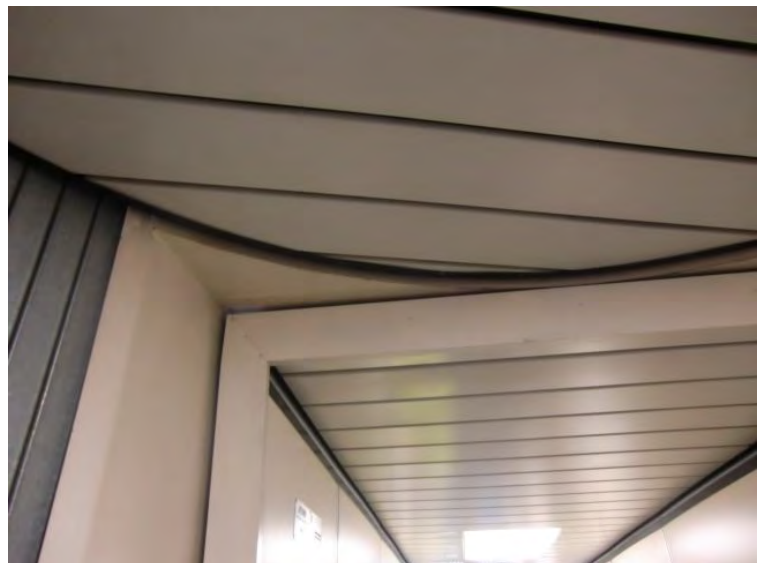
Gate 15

Chalking of the exterior paint is present throughout the exterior surfaces of the bridge. Interior paint is in fair to poor condition. The cab and bubble floor ribbed rubber is worn. Tunnel roller access covers need to be reinstalled under C tunnel.

This passenger boarding bridge is 21 years old and is in overall “fair” condition. This PBB meets NFPA 415 standards.

Exterior paint requires a pressure wash and touch up paint at a minimum. Cosmetically, the interior paint is in fair condition. Service bulletins appear to have been performed. All major lubrication points appear to have been recently serviced.

This PBB is in need of a Moderate refurbishment. In the opinion of the ASE staff, with a moderate refurbishment, the life of this PBB could be extended by approximately 8 - 10 years.

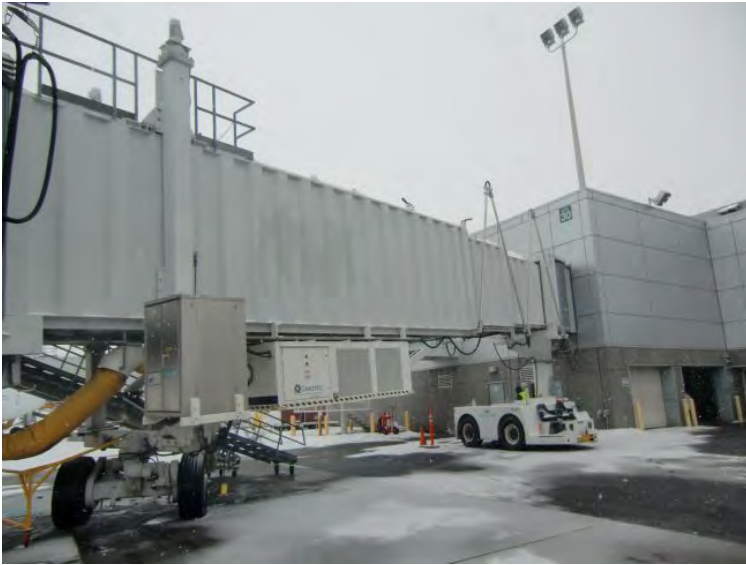
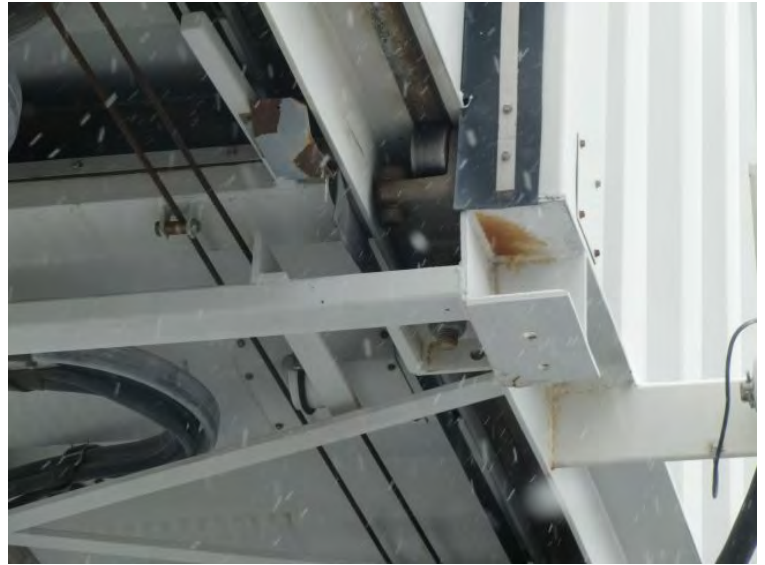
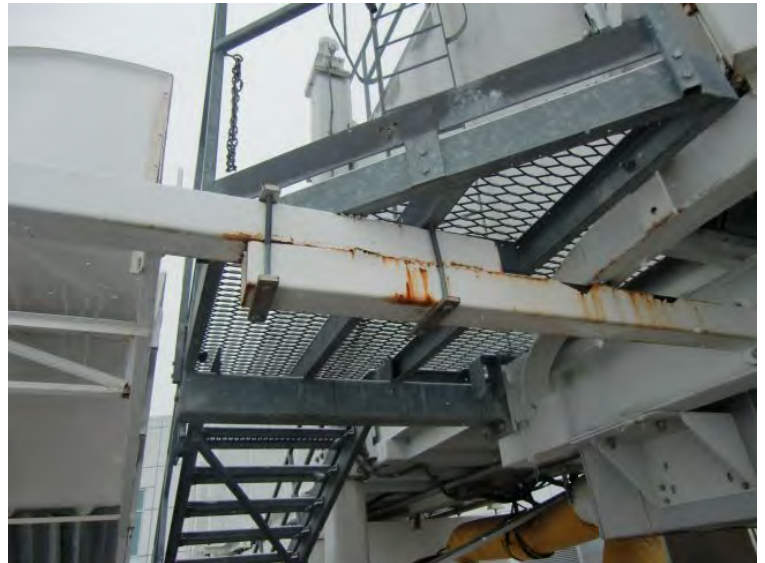
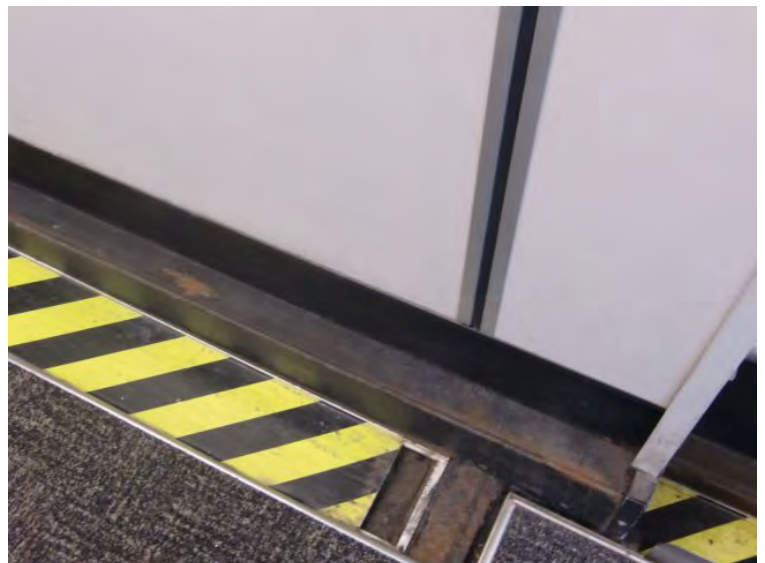
Gate 30

Square tubing for bag slide support is rusting.

Chalking of the exterior paint is present throughout the exterior surfaces of the bridge. Interior paint is in fair to poor condition. The cab and bubble floor ribbed rubber is worn. There is minor

cab rust. Most wall panels exhibit signs of water infiltration and are beginning to swell on the bottom. The firepan under the cab bubble needs to be painted.

The console faceplate has numerous cracks.

This passenger boarding bridge is 19 years old and is in overall “fair” condition. This PBB meets NFPA 415 standards.

Exterior paint requires a pressure wash and touch up paint at a minimum. Cosmetically, the interior paint is in fair condition. Service bulletins appear to have been performed. All major lubrication points appear to have been recently serviced.

This PBB is in need of a heavy refurbishment. In the opinion of the ASE staff, with a heavy refurbishment, the life of this PBB could be extended by approximately 10 years.

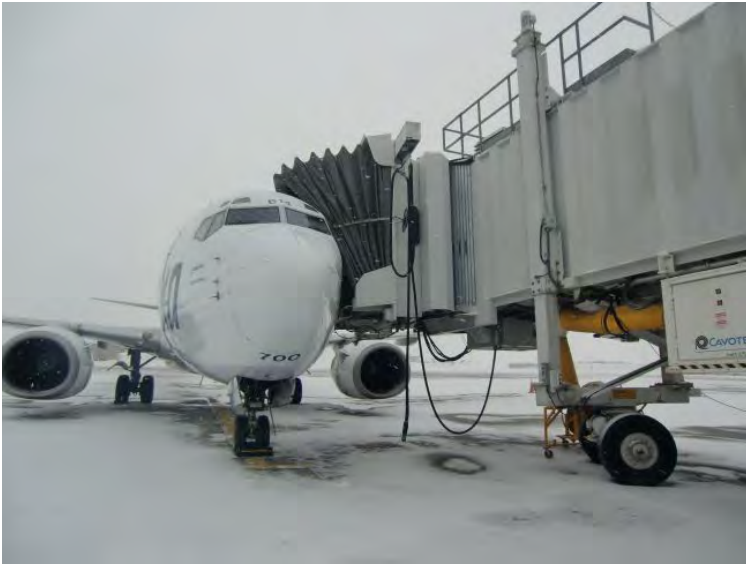
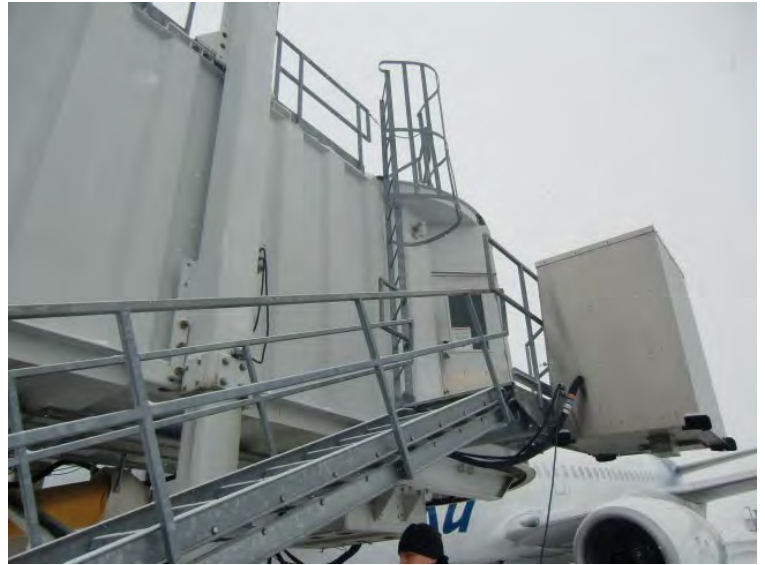
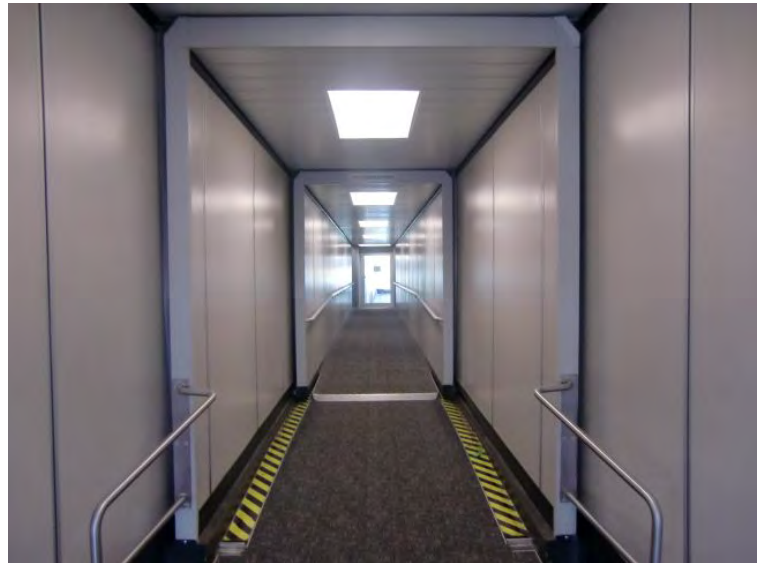
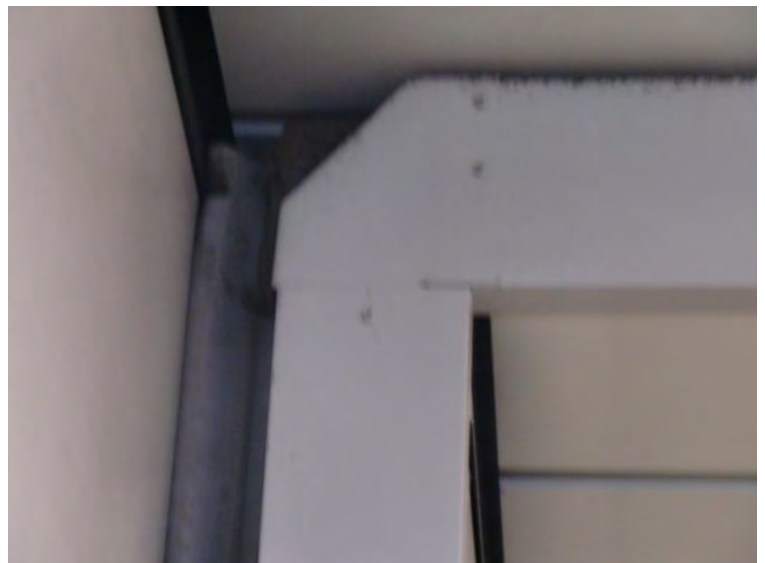
Gate 31

Chalking of the exterior paint is present throughout the exterior surfaces of the bridge. Interior paint is in fair to poor condition. The cab and bubble floor ribbed rubber is worn. There is minor

cab rust. Some wall panels exhibit signs of water infiltration and are beginning to swell on the bottom.

The console faceplate has small cracks.

Tunnel rollers are noisy indicating an out of alignment situation with a few potentially bad bearings. The rigid frame guide rollers are out of alignment. There are small holes in the canopy. One B tunnel water block is missing on the left side. The rotunda roof should be leveled. The cab roof molding is ripped.

This passenger boarding bridge is 19 years old and is in overall “fair” condition. This PBB meets NFPA 415 standards.

Exterior paint requires a pressure wash and touch up paint at a minimum. Cosmetically, the interior paint is in fair condition. Service bulletins appear to have been performed. All major lubrication points appear to have been recently serviced.

This PBB is in need of a heavy refurbishment. In the opinion of the ASE staff, with a heavy refurbishment, the life of this PBB could be extended by approximately 10 years.

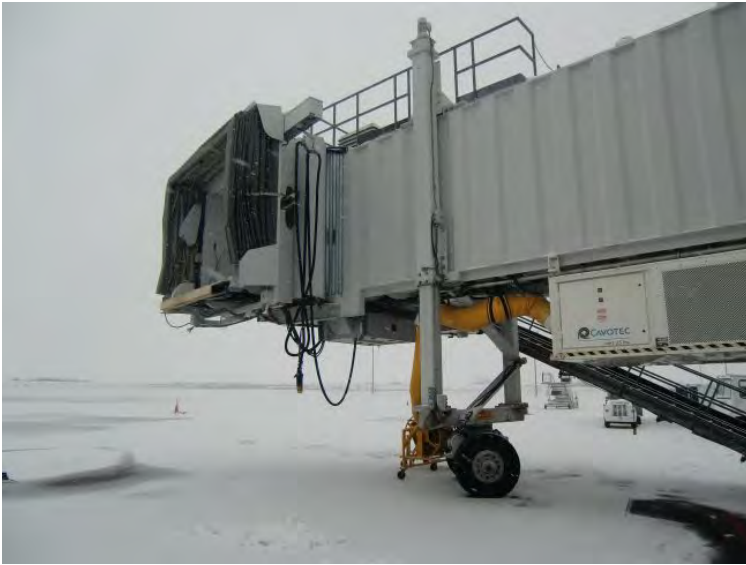
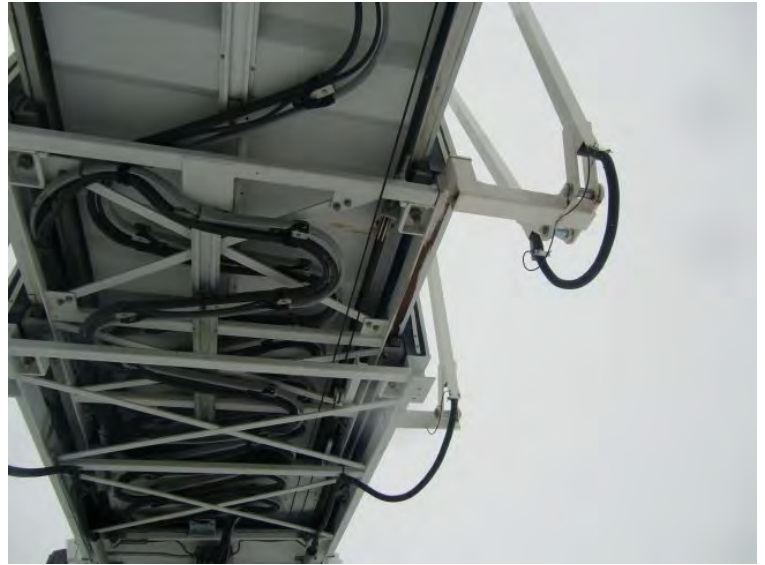
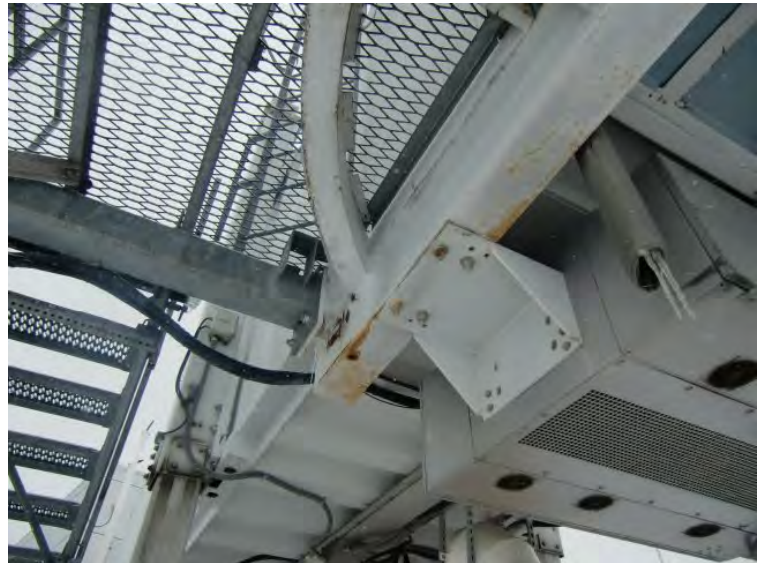
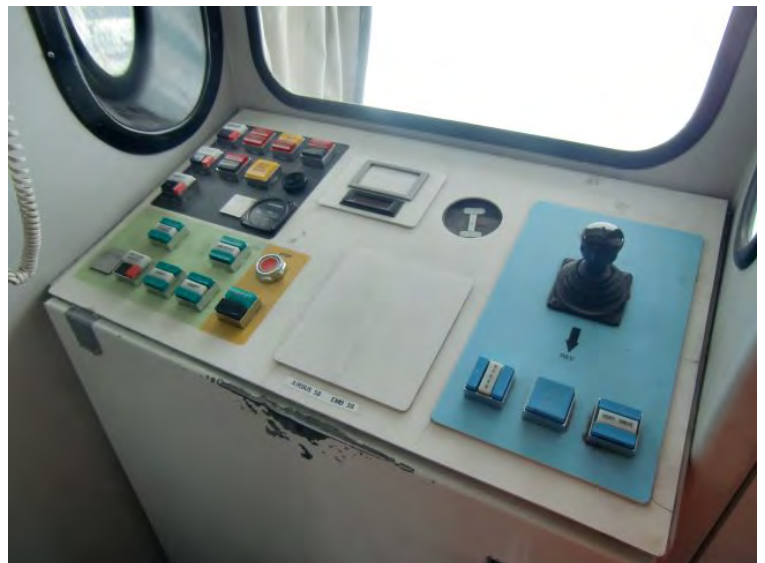
Gate 32

Chalking of the exterior paint is present throughout the exterior surfaces of the bridge. Interior paint is in fair to poor condition. The cab and bubble floor ribbed rubber is worn. The carpet is frayed at the sink ring in the rotunda.

There are small cracks in the console faceplate.

Tunnel rollers are noisy indicating an out of alignment situation with a few potentially bad bearings. The rigid frame guide rollers are out of alignment. There are small holes in the canopy and the canopy is leaking where attached to the cab. A B Tunnel interior seal is ripped.

This passenger boarding bridge is 19 years old and is in overall “fair” condition. This PBB meets NFPA 415 standards.

Exterior paint requires a pressure wash and touch up paint at a minimum. Cosmetically, the interior paint is in fair condition. Service bulletins appear to have been performed. All major lubrication points appear to have been recently serviced.

This PBB is in need of a heavy refurbishment. In the opinion of the ASE staff, with a heavy refurbishment, the life of this PBB could be extended by approximately 10 years.
