## **Airport Drive Couplet at Spotted Road**

## **Traffic Study**

April 2015

Spokane International Airport

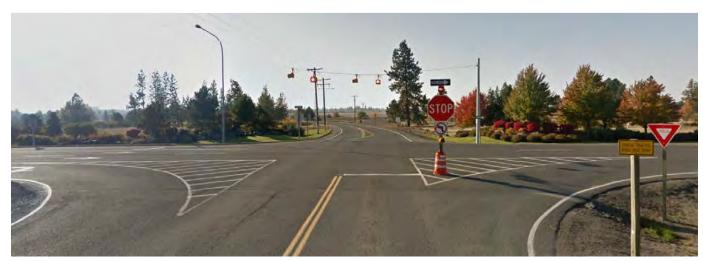
Spotted Road looking south at Airport Drive Inbound

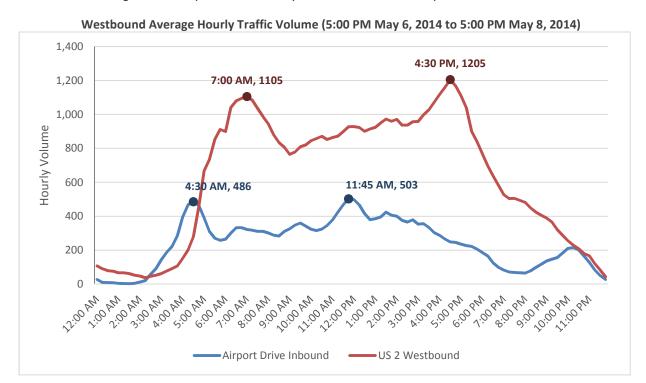
Figure 2. Comparison of Hourly Traffic Volumes on Airport Drive and US 2

In order to identify when the peak hour of traffic occurs on Airport Drive and US-2, the average hourly traffic volumes at US-2 and Spotted Road, Inbound west of Spotted Road, and Outbound east of Spotted Road were compared. Figure 2 illustrates the average hourly traffic volumes that were observed on Airport Drive and US-2 during the traffic counts. The eastbound traffic on US-2 experiences two afternoon peak hours at 2:30 PM and 4:00 PM while westbound traffic had a typical urban traffic

pattern with an AM peak hour at 7:00 AM and PM peak hour at 4:30 PM. The peak hours on Airport Drive do not occur during the typical peak hours nor during those of US-2. The eastbound peak hours on Airport Drive were at 12:45 PM and 10:45 PM while the westbound were at 4:30 AM and 11:15 AM.

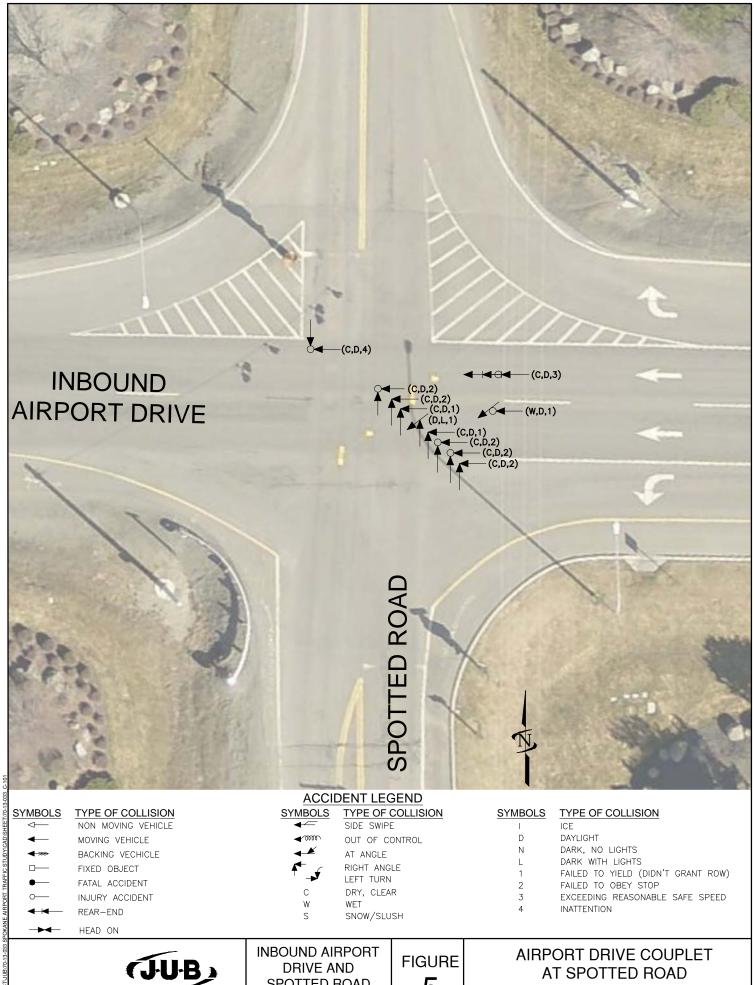
5

SPOTTED ROAD CRASHES 2009-2013

As shown in Figure 5, nearly all of the crashes at Spotted Road/Inbound involve a northbound vehicle, whereas at Outbound there are crashes involving southbound vehicles as well.

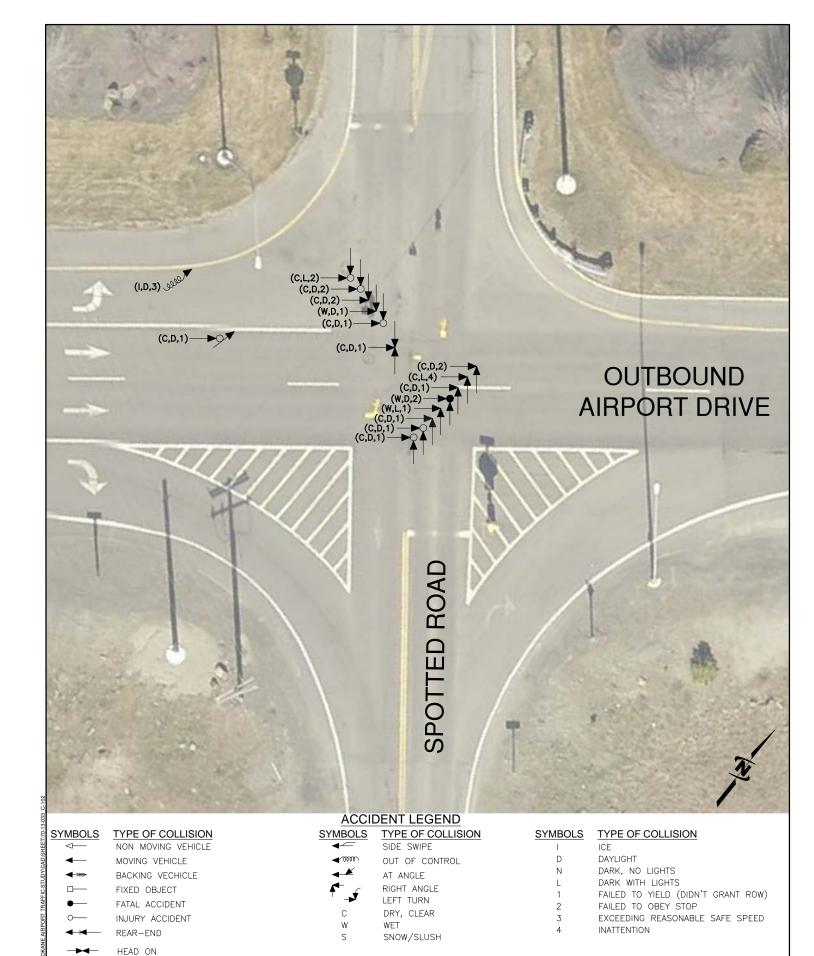
FIGURE 6

OUTBOUND AIRPORT DRIVE AND SPOTTED ROAD CRASHES 2009-2013

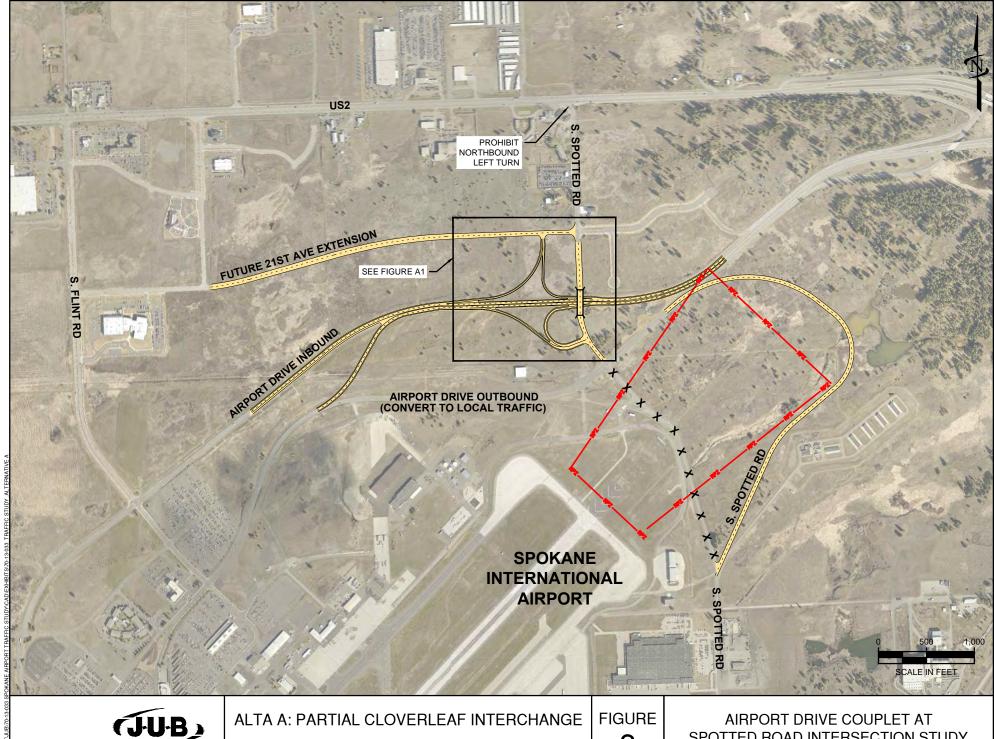
8

This alternative is the preferred alternative from the 2006 study, however, it also incorporates the 21<sup>st</sup> Avenue Extension and the realignment of Spotted Road outside of the RPZ. Outbound Airport Drive is relocated next to Inbound beginning west of Spotted Road so as to require a single structure to carry Spotted Road over Airport Drive. Existing Spotted Road would be closed south of Outbound in favor of the realigned roadway.

Interchange ramps for Outbound are situated on Spotted Road while Inbound ramps are situated on 21<sup>st</sup> Avenue west of Spotted Road. In this particular case 21<sup>st</sup> Avenue would terminate at Spotted Road, which seemed more meaningful and less costly than including a second interchange for 21<sup>st</sup> Avenue at Airport Drive. There are many options with respect to the phasing of this particular alternative.

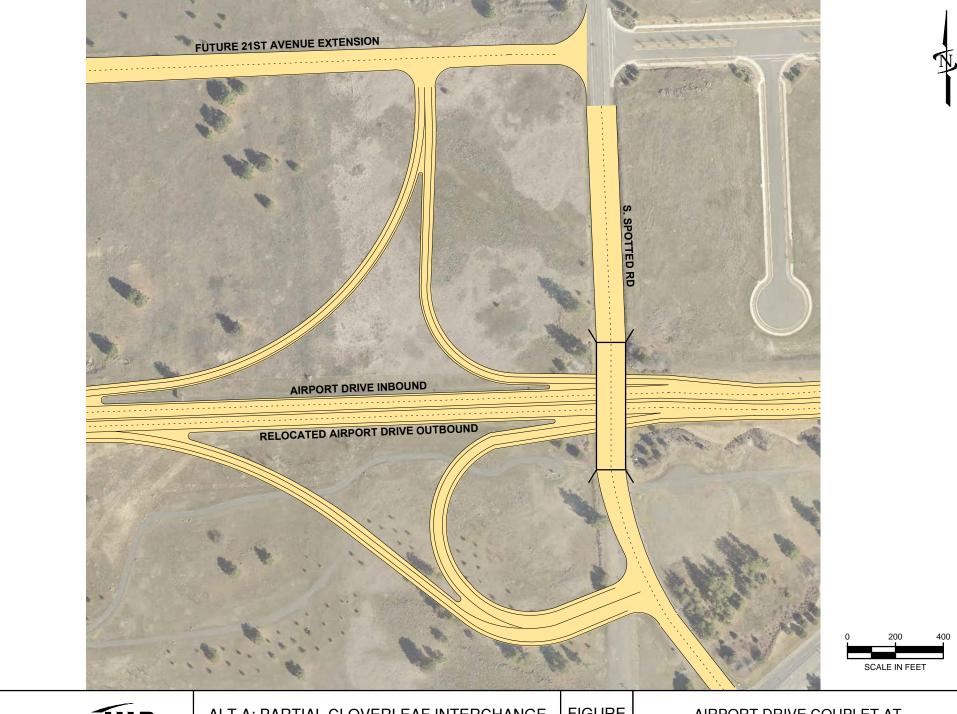
**FIGURE** 8.1

ALT A: PARTIAL CLOVERLEAF INTERCHANGE **INSET**

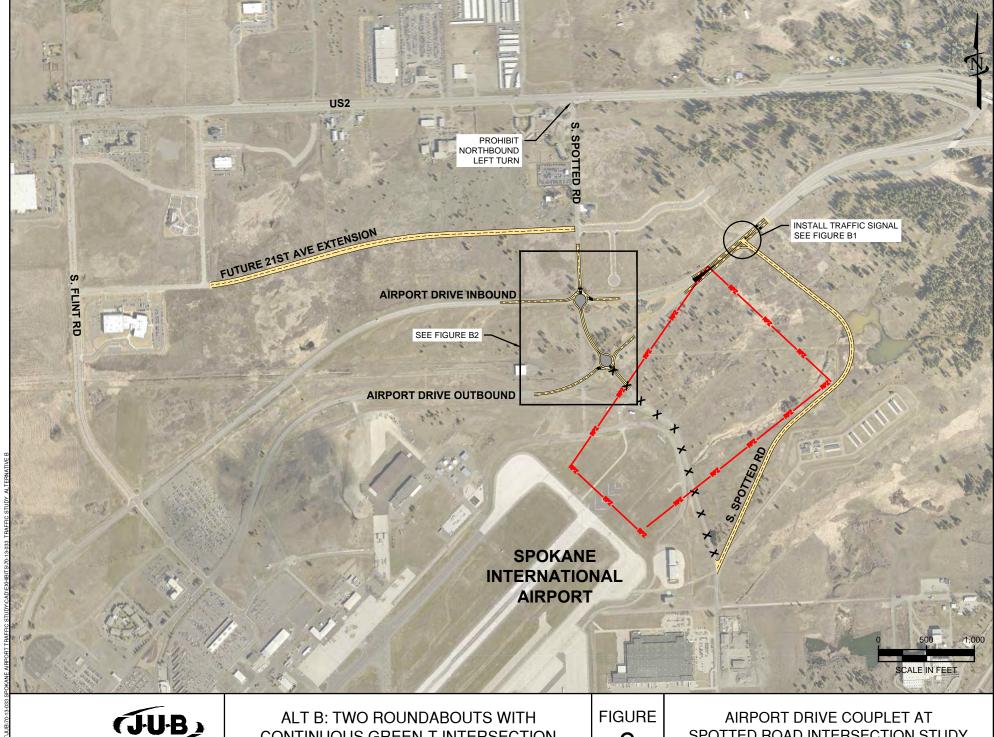
9

**CONTINUOUS GREEN-T INTERSECTION**

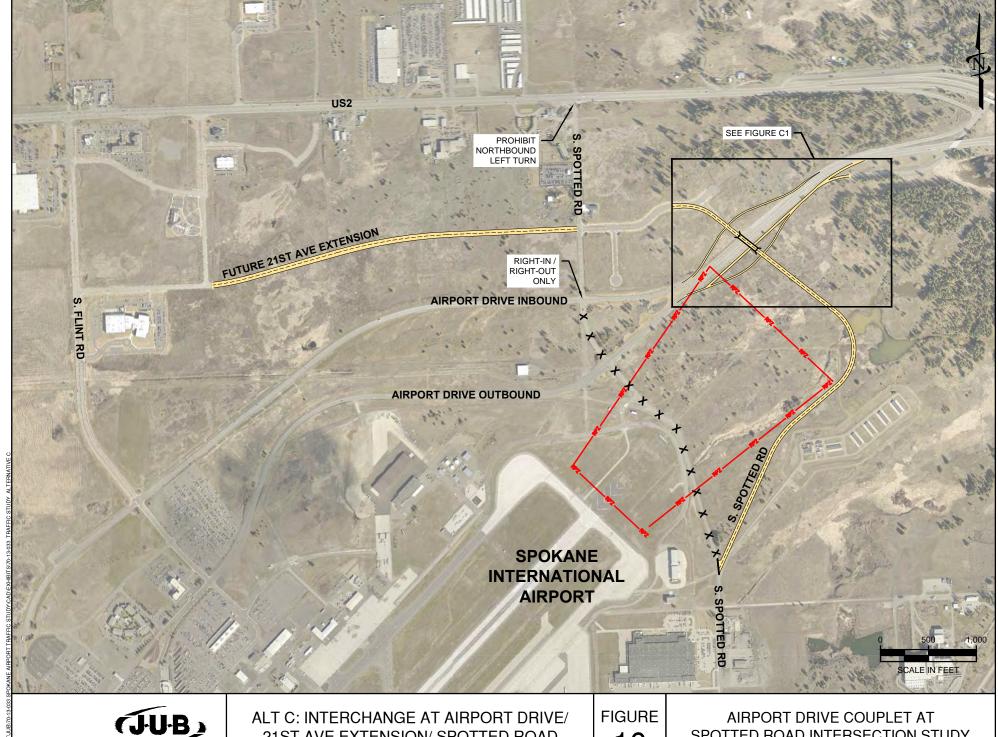
10

21ST AVE EXTENSION/ SPOTTED ROAD

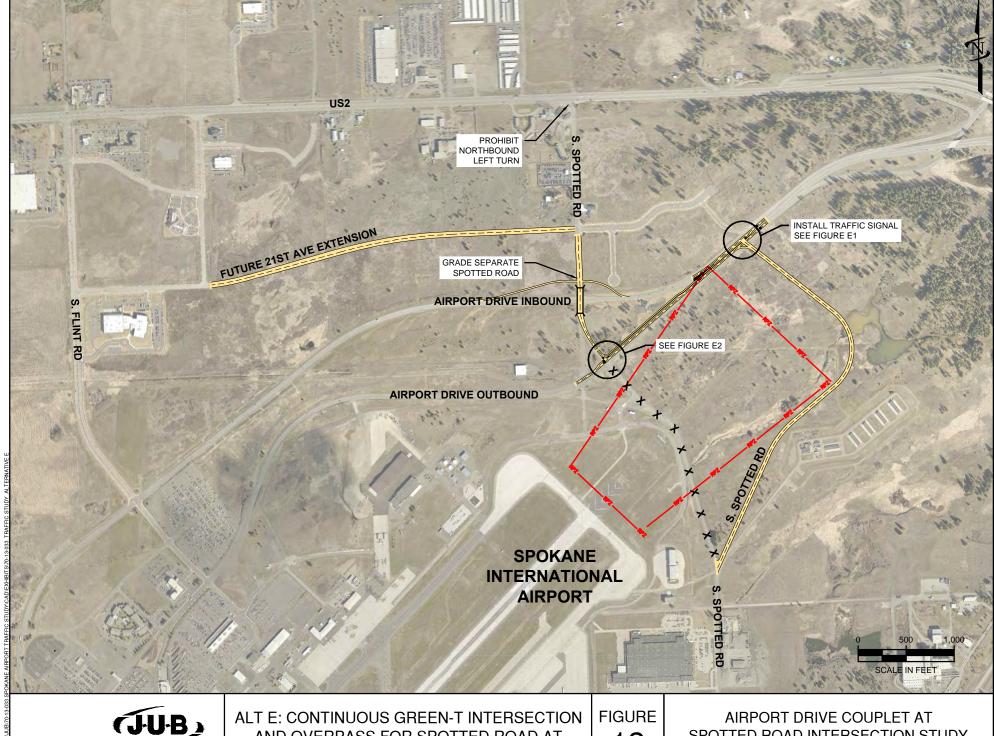
12

AND OVERPASS FOR SPOTTED ROAD AT INBOUND AIRPORT DRIVE

Alternative E: Continuous Green-T Intersection and Overpass for Spotted Road at Inbound Airport Drive This alternative was created in an attempt to retain Inbound Airport Drive as a free flow facility. It includes the Continuous Green-T intersection concept from Alternative B, but instead of a roundabout at the existing Inbound/Spotted Road intersection it would grade separate Spotted Road over Inbound. In an effort to also eliminate the weave of northbound Spotted Road traffic from south of Outbound to go to US 2, this movement would go west parallel to and north of Outbound to the existing Spotted Road and then proceed north over Inbound.
